2017 Lower American River Streambank Erosion Monitoring Report

April 2018

Prepared for:
American River Flood Control District
&
Sacramento Area Flood Control Agency

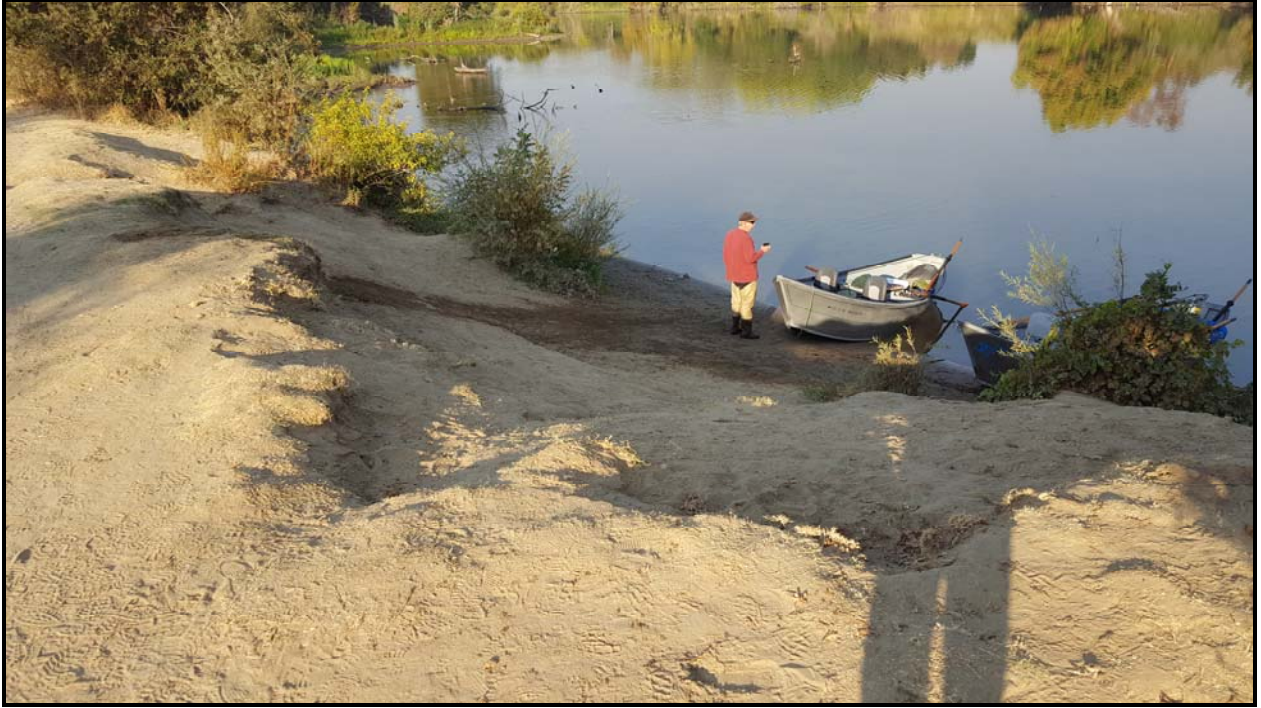
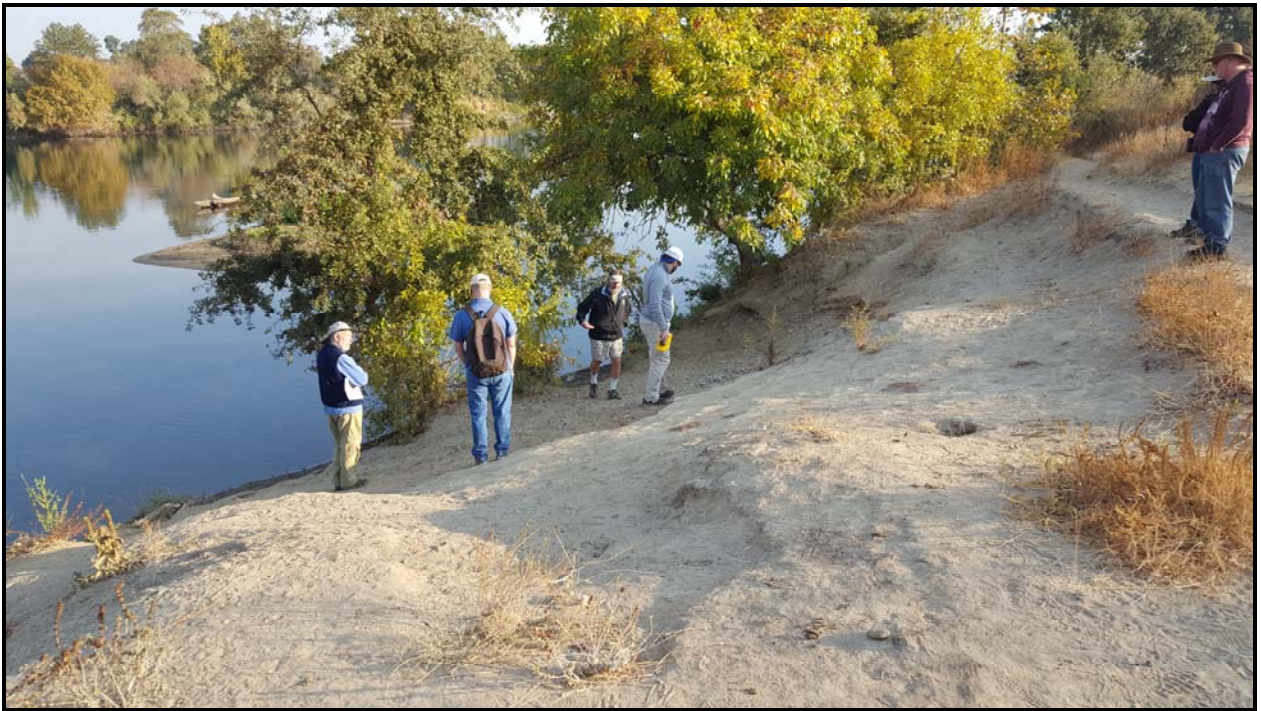
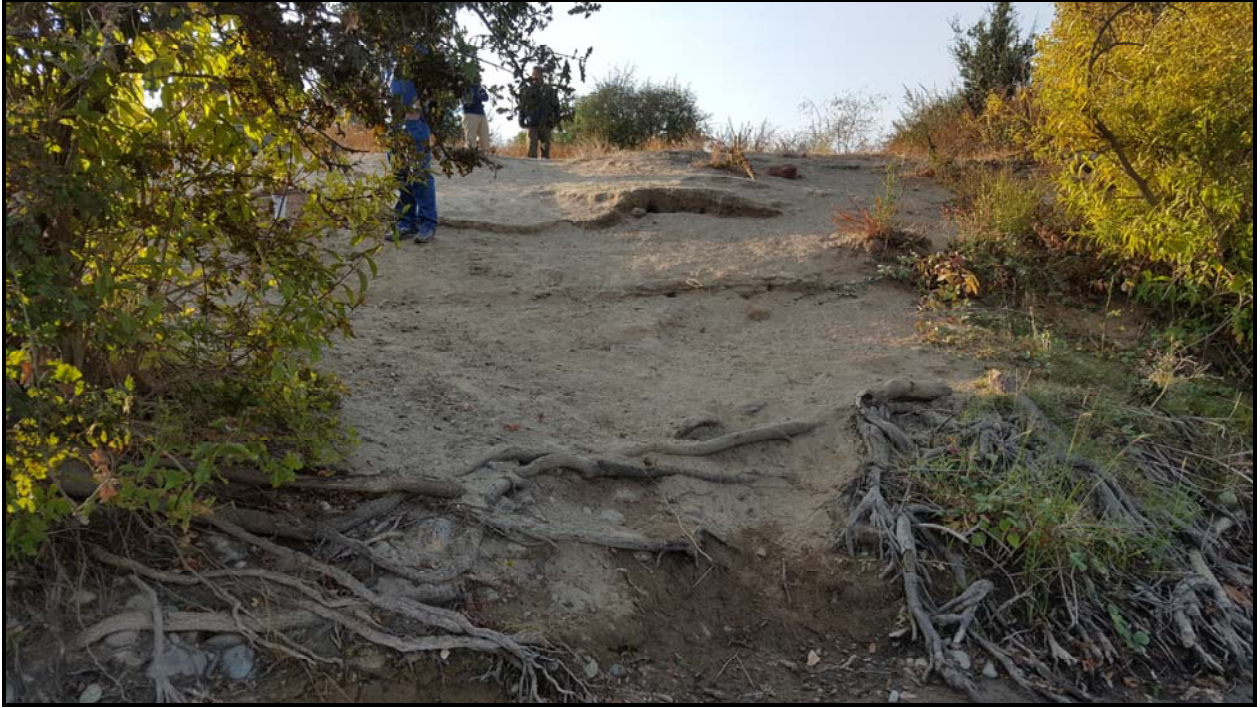
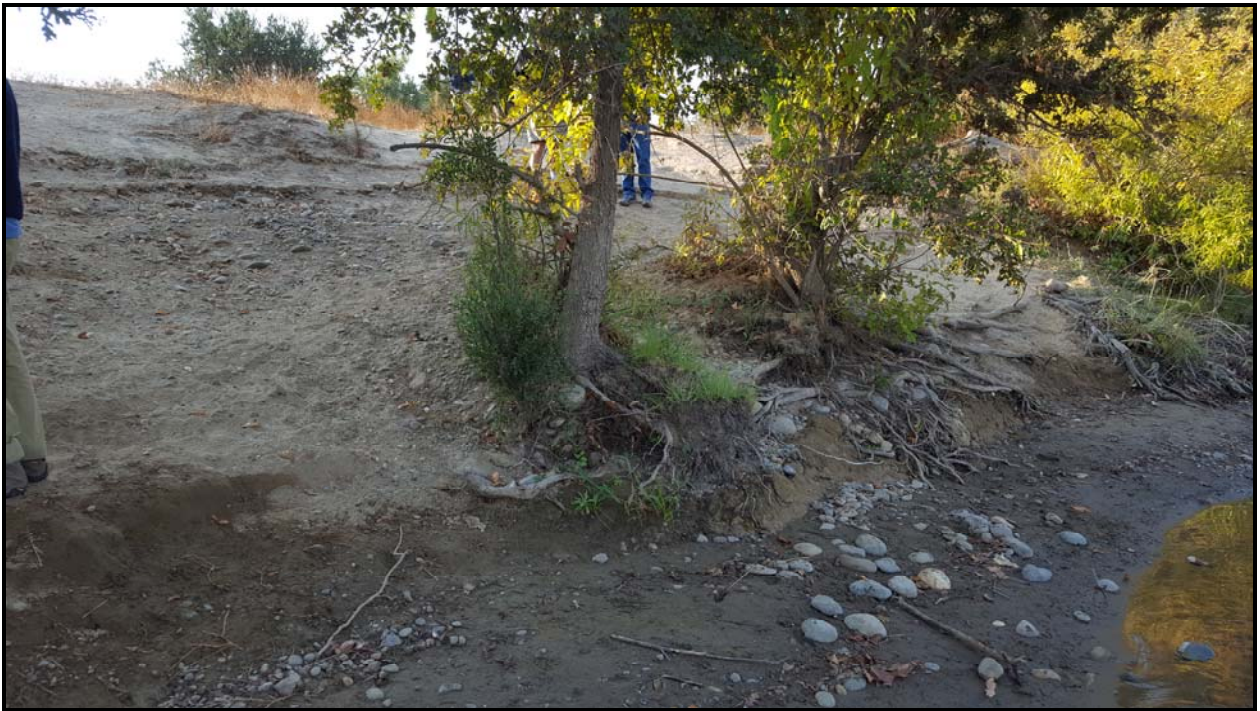
LAR RM 10.9 Left – Erosion at this site does not threaten the integrity of the levee due to the width of the berm. Planting woody vegetation on the bank would reduce the rate of erosion. However, recreational use at the site may dictate a more structural fix. Minor erosion was noted in 2010 in a confined area along the channel bank, likely due to animal activity and surface drainage. This erosion does not appear to have progressed significantly. Cross section surveys are an option that would enable the district to monitor the progression of the erosion at this site.

Site	Length	Year Identified	Conditions	Modeled Velocity	Modeled Velocity	Recreational Setting	Potential Action
River Mile				115,000 CFS	145,000 CFS		
10.9L	150 feet	2005	Poorly vegetated bank with 280 feet from channel to levee. Some minor erosion was first noted in 2010 in a confined area along the channel bank, likely a combination of animal activity and surface drainage. This erosion does not appear to have progressed significantly over the past several years. Site characteristics appear to be comparable to 2016 inspection.	1-3 fps	3-4 fps	Self-maintained walking trails at top of bank.	Establish woody vegetation thicket on bank or other biotechnical measures such as brush mattress, willow waddles or brush boxes (all supplemented with plantings), especially along waterside toe.

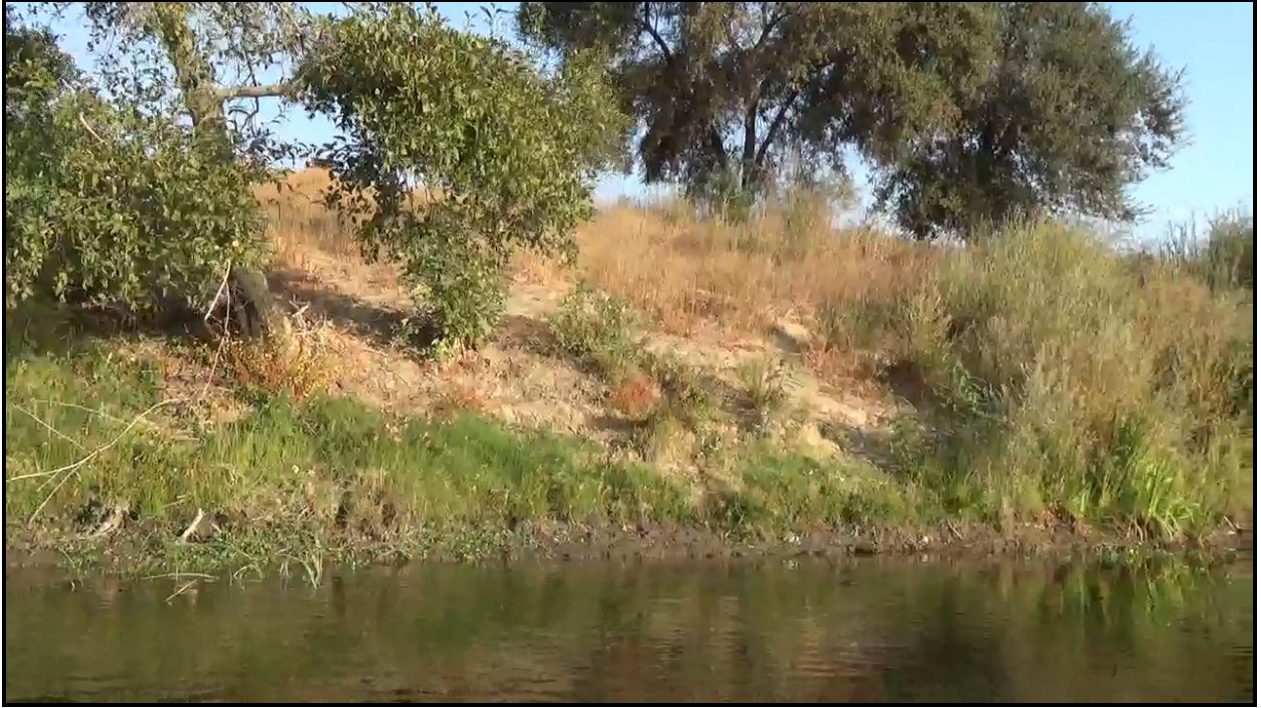
Photograph 5 – LAR RM 10.8R

LAR RM 10.8 Right – Erosion at this site does not threaten the integrity of the levee due to the width of the berm. Planting woody vegetation on the bank would reduce the rate of erosion. However, recreational use at the site may dictate a more structural fix. Observed site characteristics are comparable to the 2016 inspection.

10.8R	120 feet	2005	Site characteristics are comparable to 2016 based on field inspection. Poorly vegetated, undercut bank with 175-foot berm to levee. Signs of recreational use are apparent at the site.	1-3 fps	1-3 fps	50 feet to Equestrian Trail and 85 feet to Bike Trail.	Establish woody vegetation thicket on bank or other biotechnical measures such as brush mattress, willow waddles or brush boxes (all supplemented with plantings), especially along waterside toe.

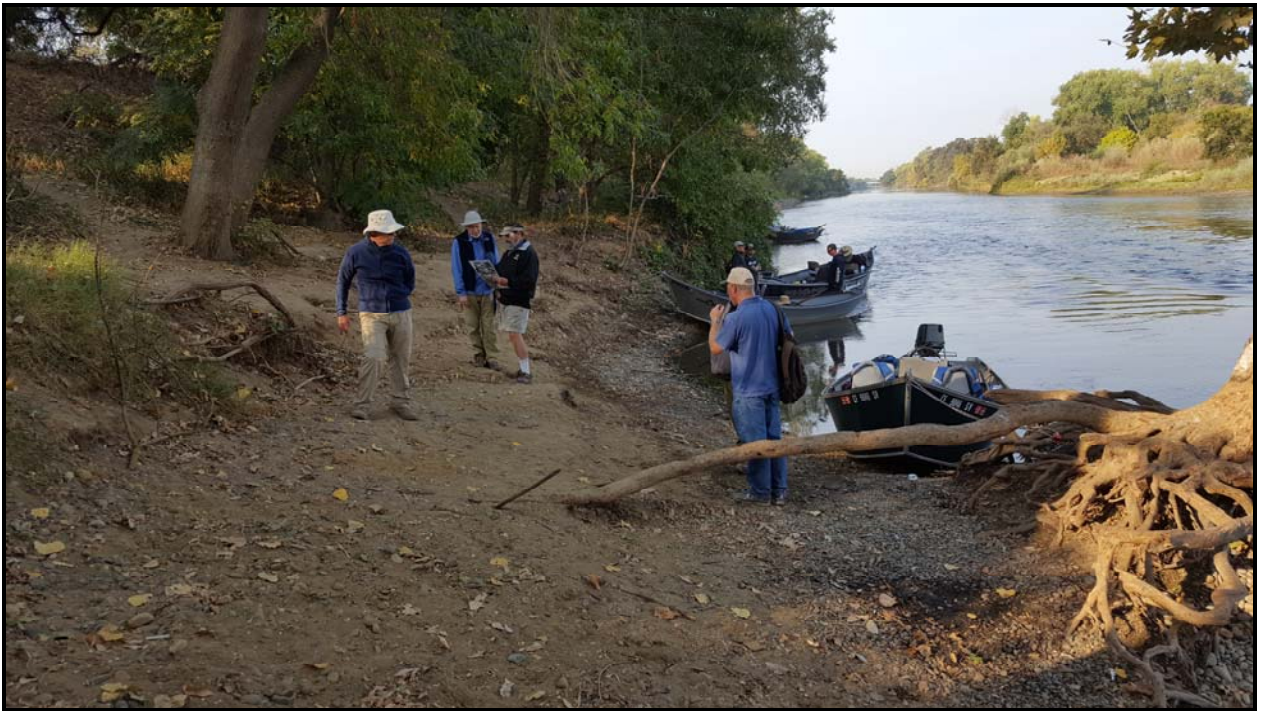
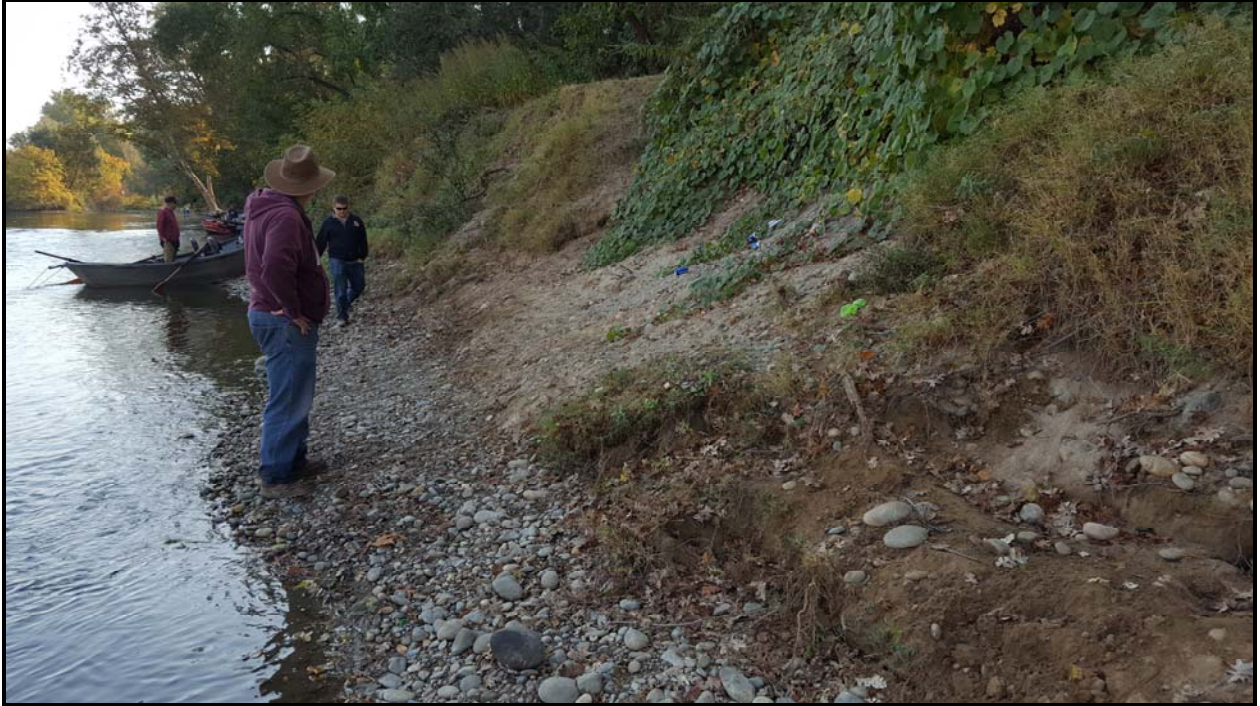
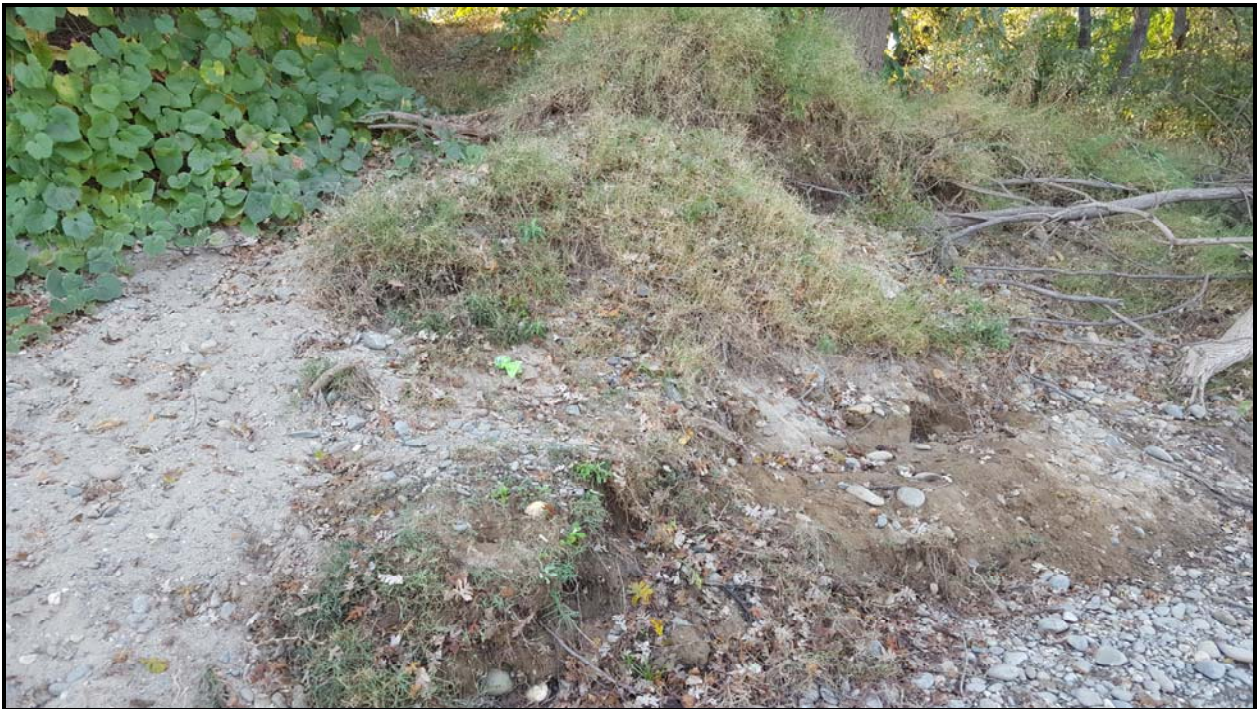
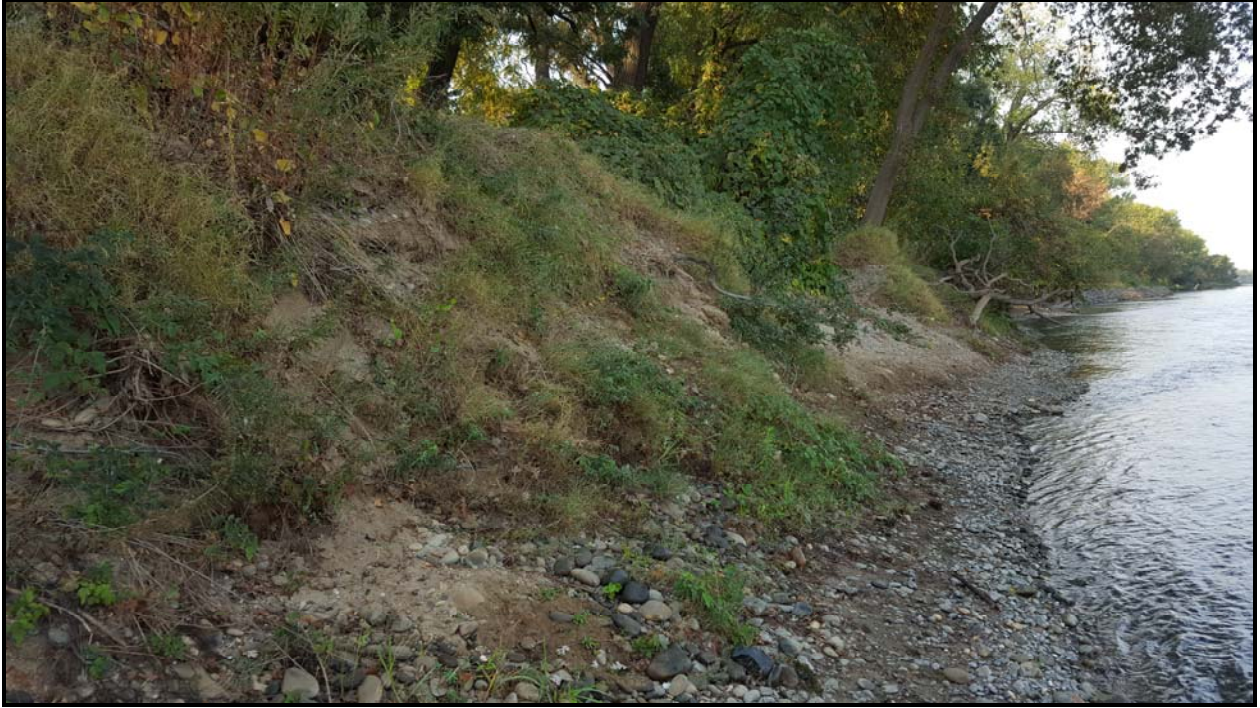
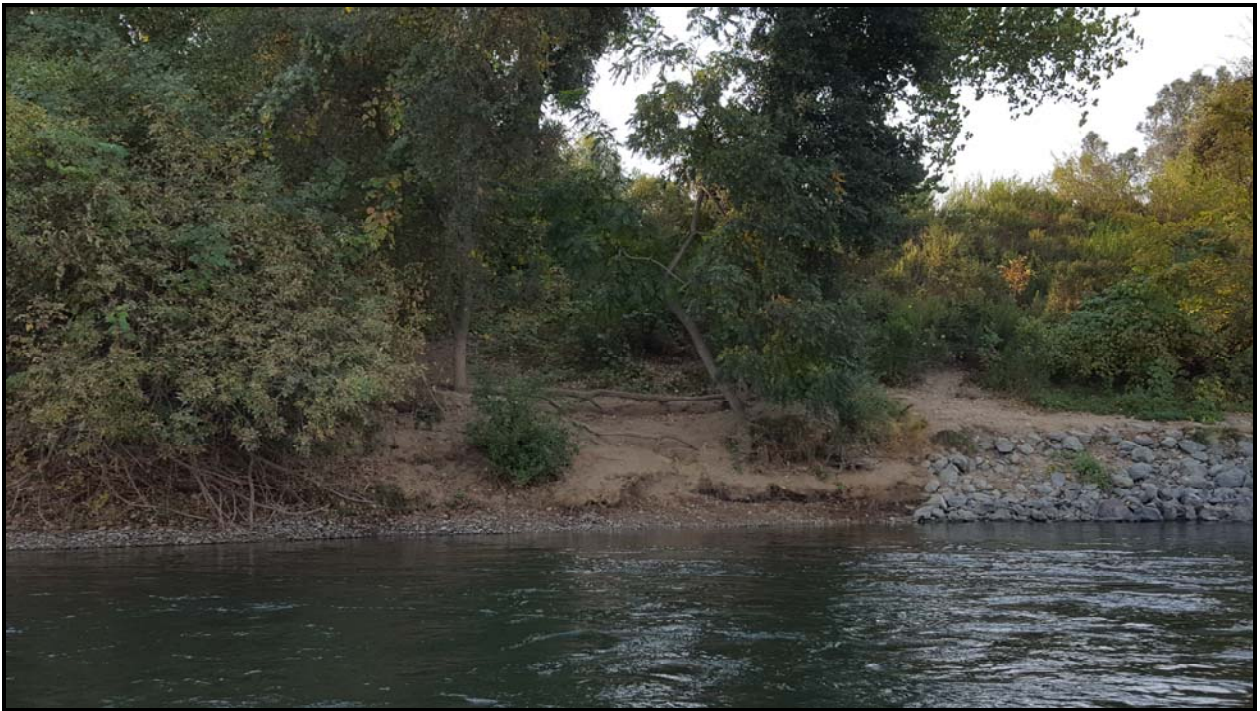
LAR RM 10.5 Left – Erosion at this site does not appear to threaten the integrity of the levee due to the width of the berm. However, the soils at the site appear to be non-cohesive soils that would likely erode rapidly during a high water event, especially if the vegetative cover continues to degrade due to high recreational use. Planting woody vegetation on the bank would reduce the rate of erosion. Recreational use at the site may dictate a more structural fix. Erosion at the upstream portion of the site does not appear to have progressed significantly since the 2016 inspection. A 20 foot section along the downstream end of the site continues to show signs of minor erosion. Since the 2016 inspection, fewer rodent burrows were observed along the steep middle and upper bank. If erosion continues to progress at the site, a more structural fix will be required. Repair of the site will need to accommodate intense recreational use.

The downstream portion of the site has been repaired by the US Army Corps of Engineers as part of the Sacramento River Bank Protection Program. Repairs included placing riprap along the bank as well as planting vegetation.

10.5L	150 feet	2006	Poorly vegetated bank with non-cohesive soils and heavy recreational use. Upstream portion of site has not degraded significantly since 2016 inspection. Small section (20 feet) along downstream end of site continues to show signs of minor erosion. Fewer rodent burrows were observed in the steep upper and middle bank as compared to 2016. Downstream reach has been repaired by the Army Corps of Engineers under the Sacramento River Bank Protection Program.	1-3 fps	2-4 fps	Adjacent to Equestrian Trail and foot path.	Repair of the site will need to integrate recreational use. Due to the challenges with repairs at RM 10.0 (see 2006 report), vegetation is not likely to be successful due to the intense recreational use. Cobbles with vegetation or other biotechnical measures such as brush mattress, willow waddles or brush boxes (all supplemented with plantings) are a possible solution. The downstream reach has been repaired as part of the Sacramento River Bank Protection Project, also known as the Sac Bank Program.

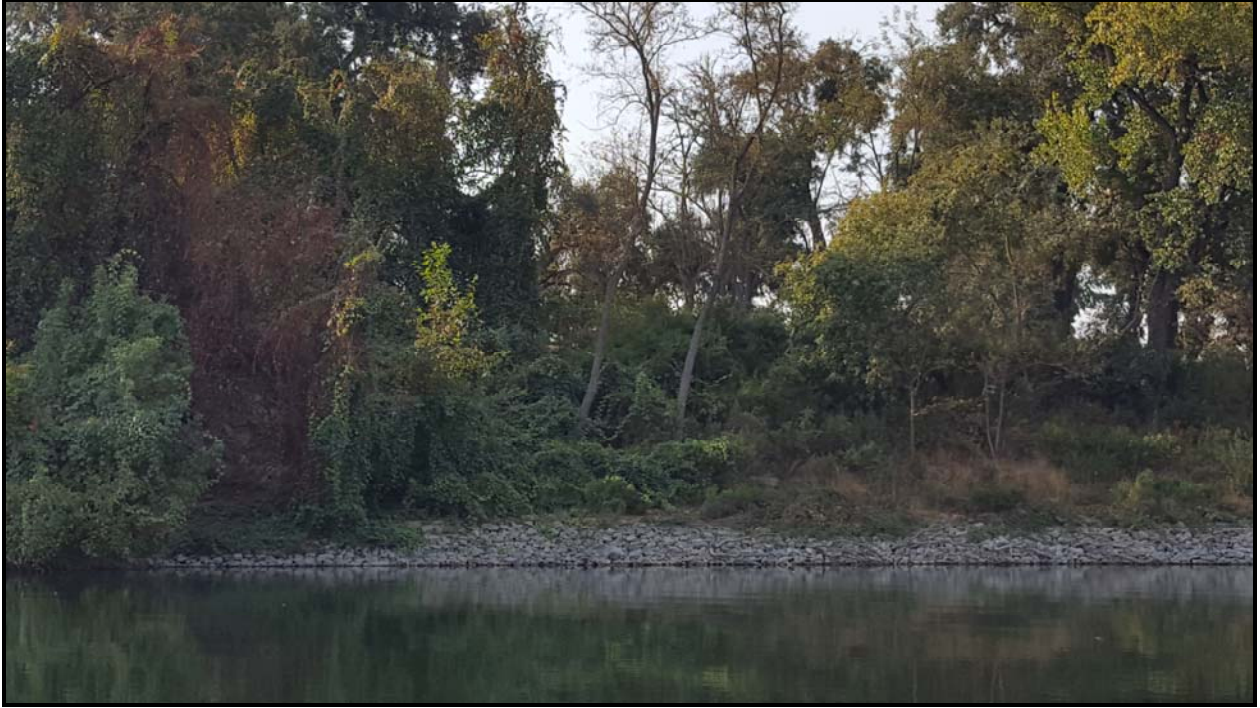
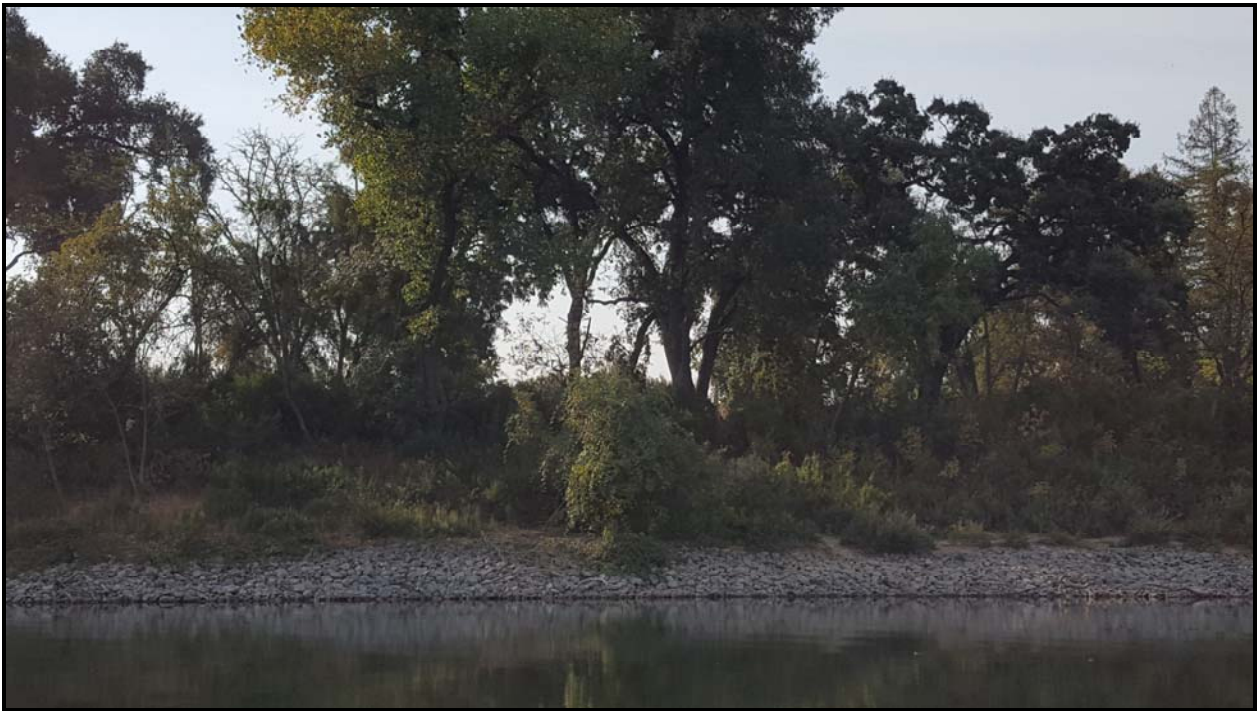
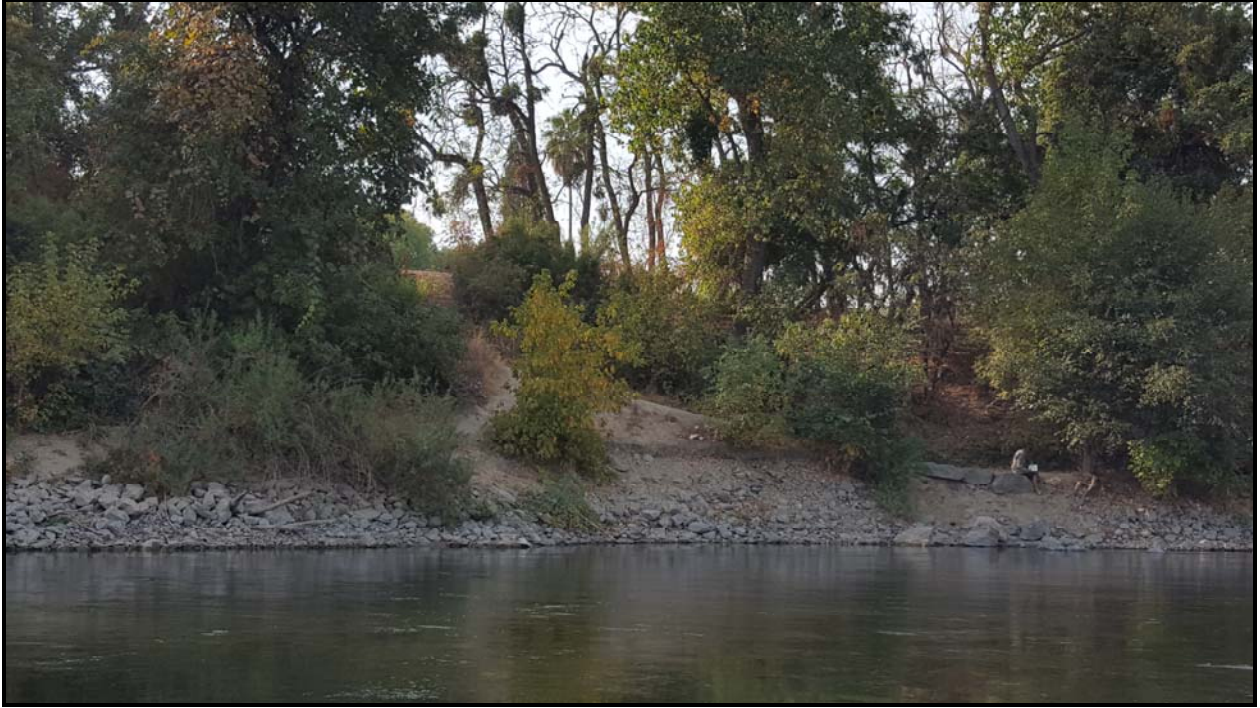
LAR RM 9.8 Left – This site has been repaired by the US Army Corps of Engineers as part of the Sacramento River Bank Protection Program. Construction activities included repairing the eroded sections of the site by placing riprap along the bank as well as planting vegetation.

The west end of this site (downstream, formerly known as Site 10.0L) was previously repaired and woody vegetation was planted on the waterside edge of the berm. This planting appears to have reduced the rate of erosion as it has not progressed significantly since 2016. Observations indicate the cobble and the finer particles on the surface of the berm continue to erode, exposing some of the underlying riprap. At the downstream end of the site, some of the larger rocks delineating the pedestrian access ramp have been displaced and settled on the lower bank. This appears to be the result from primarily pedestrian and recreational activity. However, this condition is largely aesthetic and the structural component appears to be intact. The repair appears to be holding up relatively well, however it is highly correlated to the amount of pedestrian use at the site. The District has historically performed minor maintenance in the area to stabilize the pedestrian path.

9.8L	1150 feet	2005	Erosion has historically occurred due to high pedestrian access / recreational use, however it does not appear to have progressed significantly since 2016 aside from the displacement of some of the larger rocks that delineate the pedestrian access ramp. The upstream reach has been repaired by the Army Corps of Engineers under the Sacramento River Bank Protection Program.	4-6 fps	5-7 fps	65 feet to levee maintenance road	The upstream reach has been repaired as part of the Sacramento River Bank Protection Project, also known as the Sac Bank Program. The downstream reach was previously repaired and appears to be holding up relatively well.

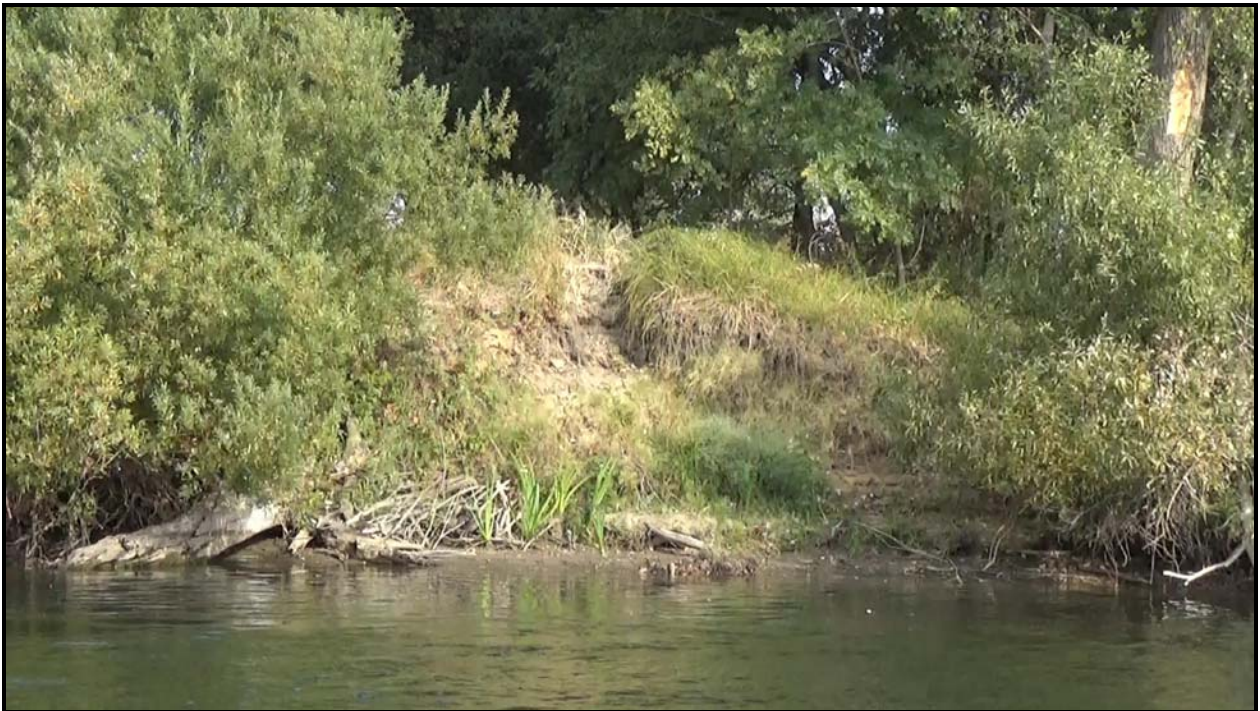
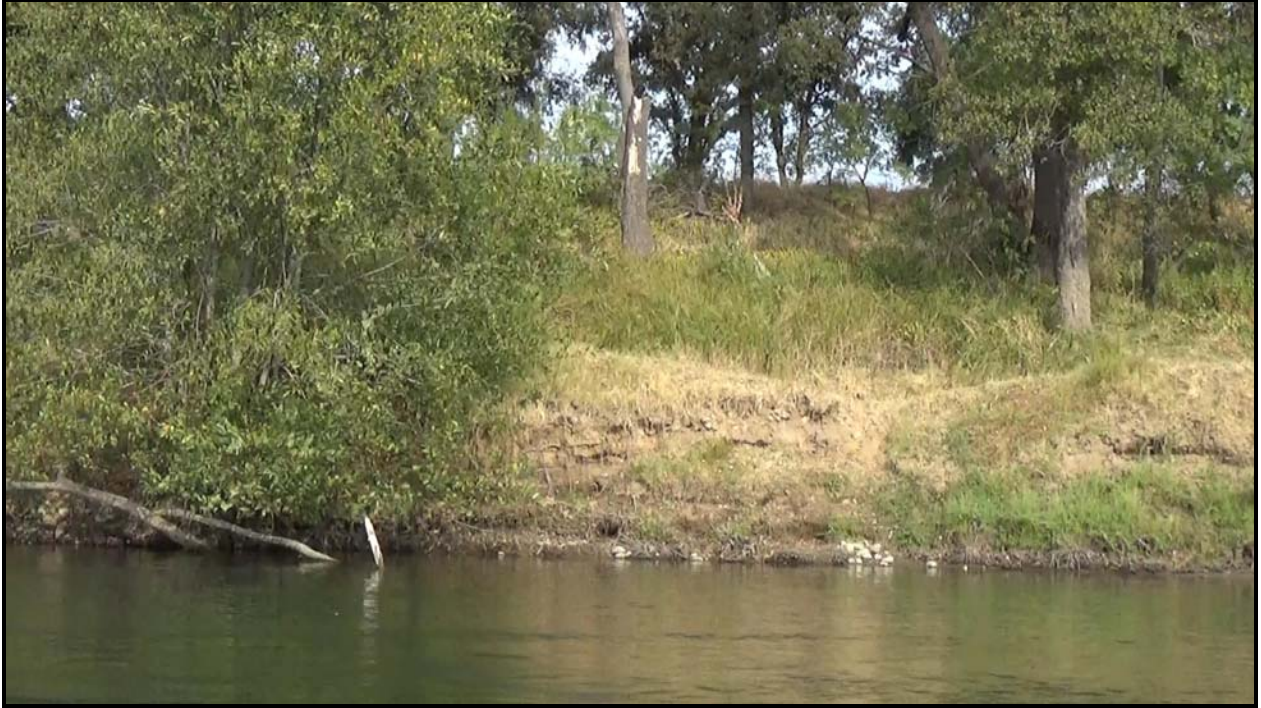
LAR RM 8.8 Right – This site was previously studied by the Sacramento River Bank Protection Project as the “Site 5 extension” (Lower American River – Site 5 Extension, US Army Corps of Engineers, prepared by HDR, March 2002). Consideration should be given to repairing the scalloping at this site to reduce the rate of erosion. Consideration should also be given to taking action over the entire reach to preserve the berm, equestrian trail, and existing mature vegetation. No visible progression of erosion or undercutting on vertical banks was observed during the inspection, and it should be noted that the vegetative cover appears to be similar to the 2016 inspection. Due to the high level of recreational activity at this site, a cross section survey of the entire reach was performed by MBK in March 2013. Subsequent surveys could be performed as needed to monitor the rate of erosion and degradation of the bank.

8.8R	280 feet	2005	Undercut, vertical bank sloughing into river, 100 foot berm to levee. Vegetative cover is similar to 2016. Undercutting along vertical banks does not extend below water level.	3-5 fps	4-6 fps	Adjacent to Equestrian Trail ; 60 feet to Bike Trail.	Armor bank at and below low flow shoreline with rock and treat upper bank with biotechnical measures such as brush mattress, willow waddles or brush boxes (all supplemented with plantings). Cross section survey was performed by MBK in March 2013 to monitor erosion and degradation of bank.

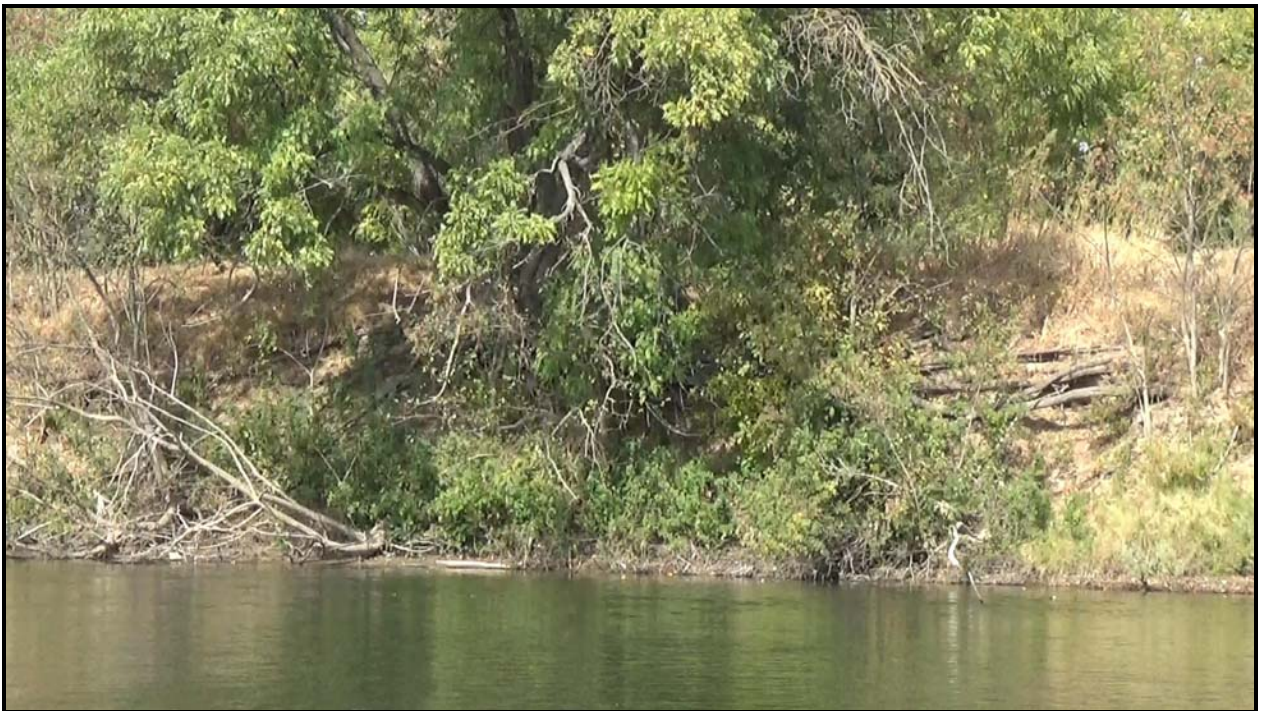
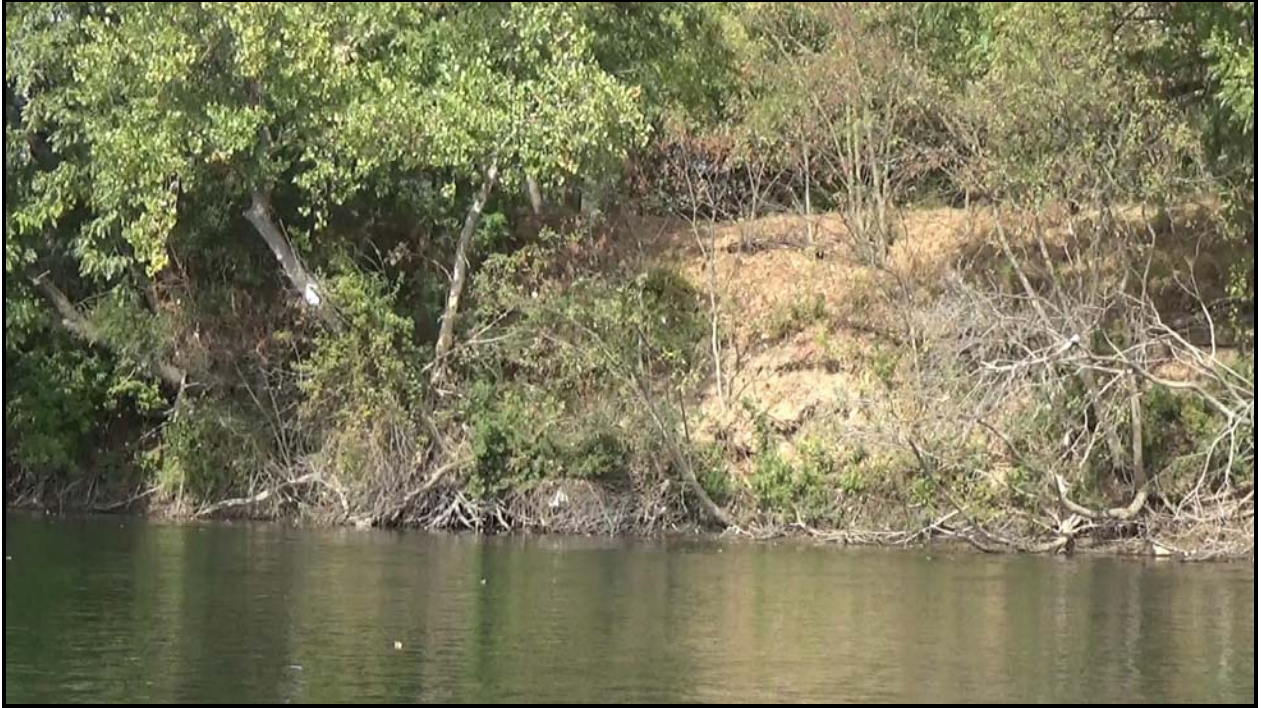
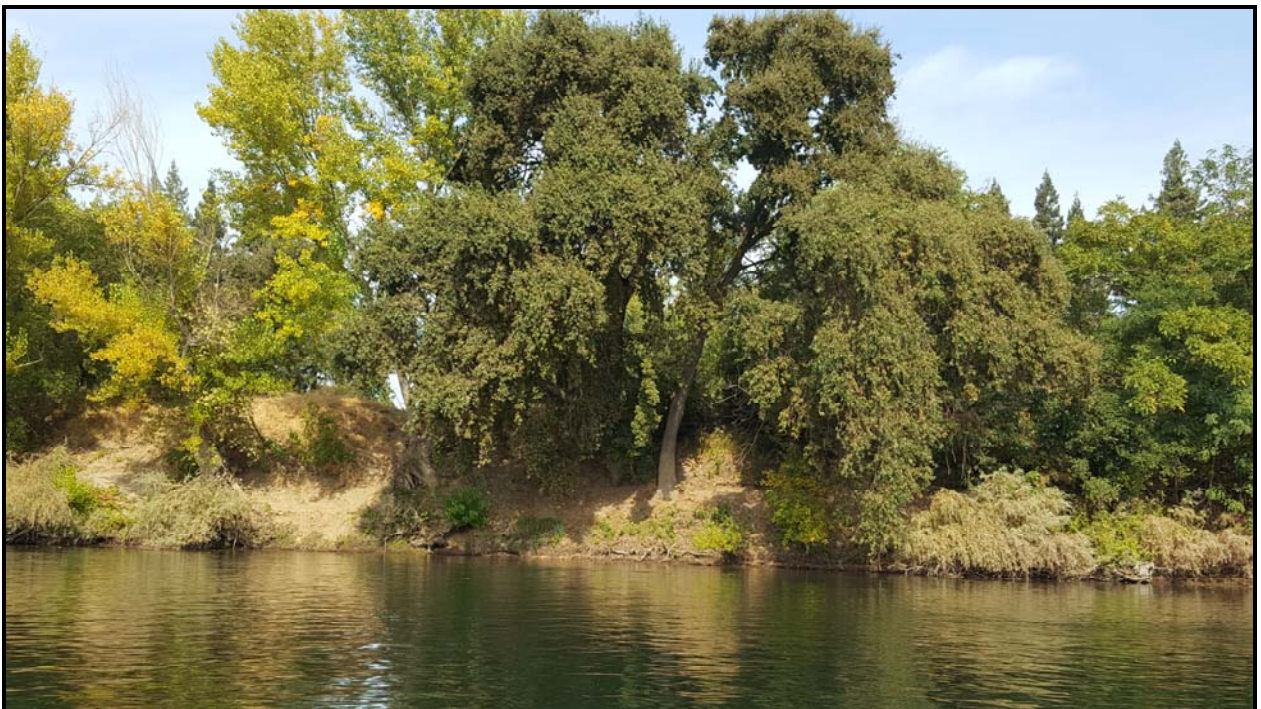
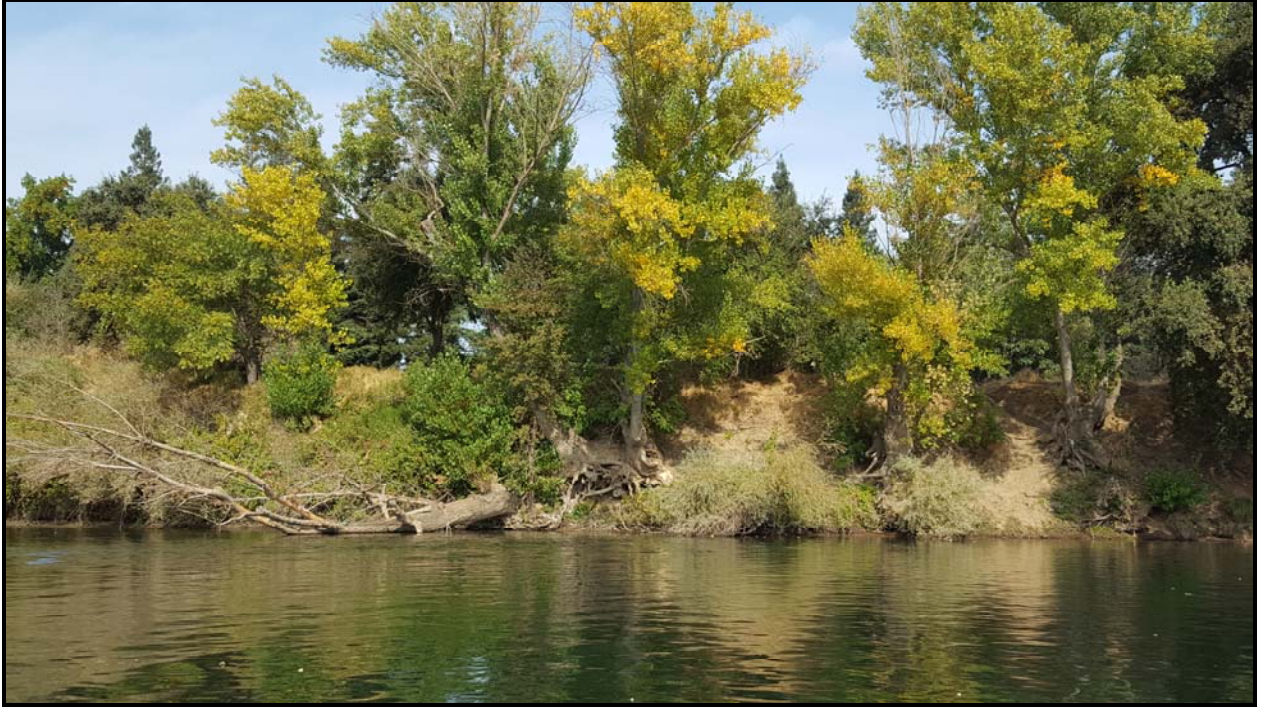
LAR RM 7.5 Right – Erosion at this site does not threaten the integrity of the levee due to the width of the berm. Planting woody vegetation on the bank may reduce the rate of erosion and should be considered. The width of the berm is substantial (greater than 100 feet) at this site. However, the apparent erodability of the exposed soils could lead to significant erosion during a high flow event, although it is not anticipated to erode the entire berm in one flood event. Armoring the bank with biotechnical measures such as brush mattress, willow waddles or brush boxes (all supplemented with plantings) should be considered to preserve the berm and bike trail. Erosion at this site does not appear to have progressed since the 2016 inspection. Vegetative cover also appears to be similar to 2016.

7.5R	820 feet	2005	No visible progression of erosion compared to 2016 field inspection. Undercut, vertical bank sloughing into river, 150 foot berm to levee. Vegetative cover is similar to 2016.	3-6 fps	5-6 fps	40 feet to Equestrian Trail; 80 feet to Bike Trail.	Restore slope and armor bank.

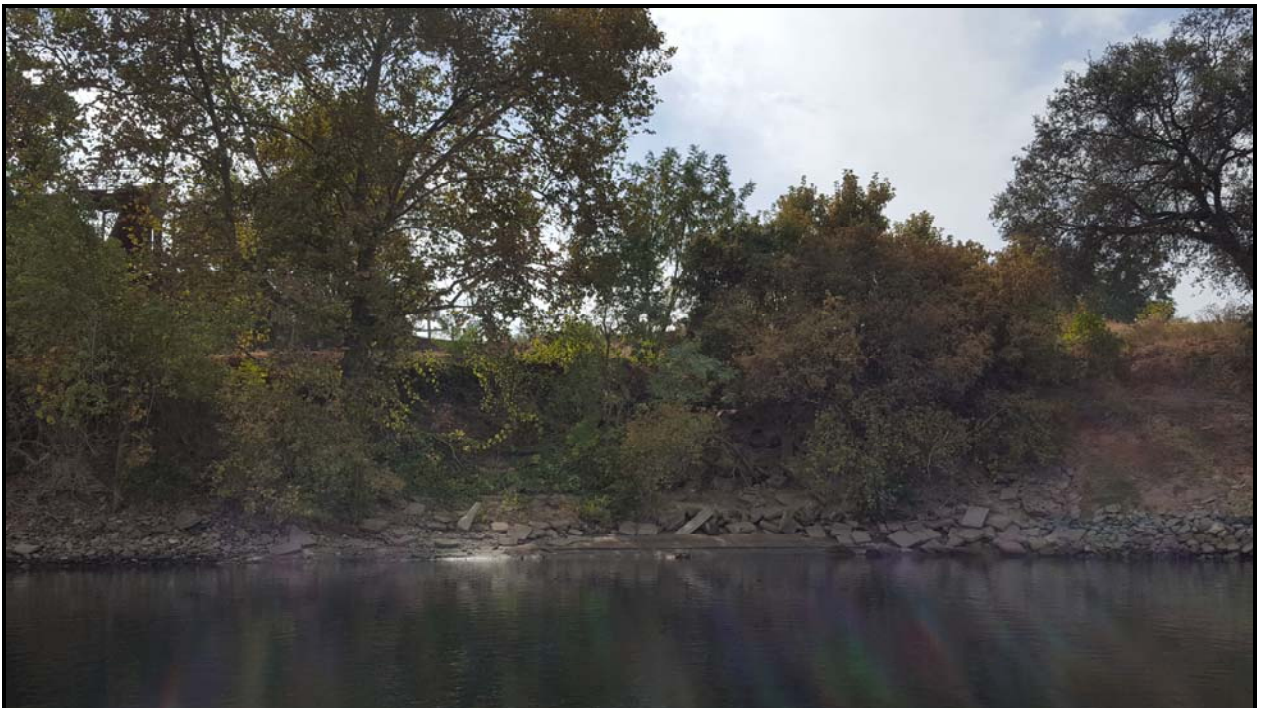
LAR RM 2.7 Left – This site has been partially repaired by the Army Corps of Engineers under the Sacramento River Bank Protection Program. As previously noted, it was observed that the repair efforts do not appear to encompass the entire area experiencing erosion, specifically the upstream portion of the site. Erosion at the upstream end of the site threatens the integrity of the floodwall because the streambank is steeper than 3:1. This floodwall has been previously studied by MBK (Alternatives Analysis for Replacement of the Existing Floodwall at Lower American River, River Mile 2.7, March 2007). This report concluded that a failure of the wall at or below flows of 160,000 cfs would lead to localized flooding, as shown in Figure 3, because flooding would be contained by high ground that surrounds the wall. However, so long as this

floodwall is an element of the Sacramento River Flood Control Project, the integrity of the floodwall should be maintained. This site does not appear to represent an immediate threat to public safety because of high ground located behind the levee and floodwall; however, a more detailed site analysis could be performed to determine if corrective action is required.

2.7L	700 feet	2006	Site has been partially repaired by the Army Corps of Engineers under the Sacramento River Bank Protection Program. Repair efforts do not appear to encompass all areas experiencing erosion, specifically the upstream end of the site.	1-3 fps	2-4 fps	Private property, limited public access.	Extend the repair efforts further upstream to include the erosion near the existing floodwall (approximately 350 feet).
Sac River 60.3L	330 feet	2006	Site is north of the old water intake facility. Streambank above waterline is over steepened with poorly vegetated bank and non-cohesive soils. Erosion historically has migrated toward the access road on the bench. The District has historically performed minor maintenance in the area to address erosion at the top of the slope. Most trees along levee slope have exposed roots. The large tree on the upper slope that caught fire and fell towards the river in 2013 is no longer on the bank, but the void from the root wad remains on the upper bank. Vegetative cover along the lower bank observed in 2016 is no longer present.	>3 fps	>3 fps	Bike trail at top of bank. High recreational use.	Fill with vegetation or biotechnical measures such as brush mattress, willow waddles or brush boxes (all supplemented with plantings). Site (including void created by uprooted portion of tree) should continue to be monitored and maintained, especially during and after rainfall.

Photograph 22 - LAR RM 2.7L (1), upstream of repair site

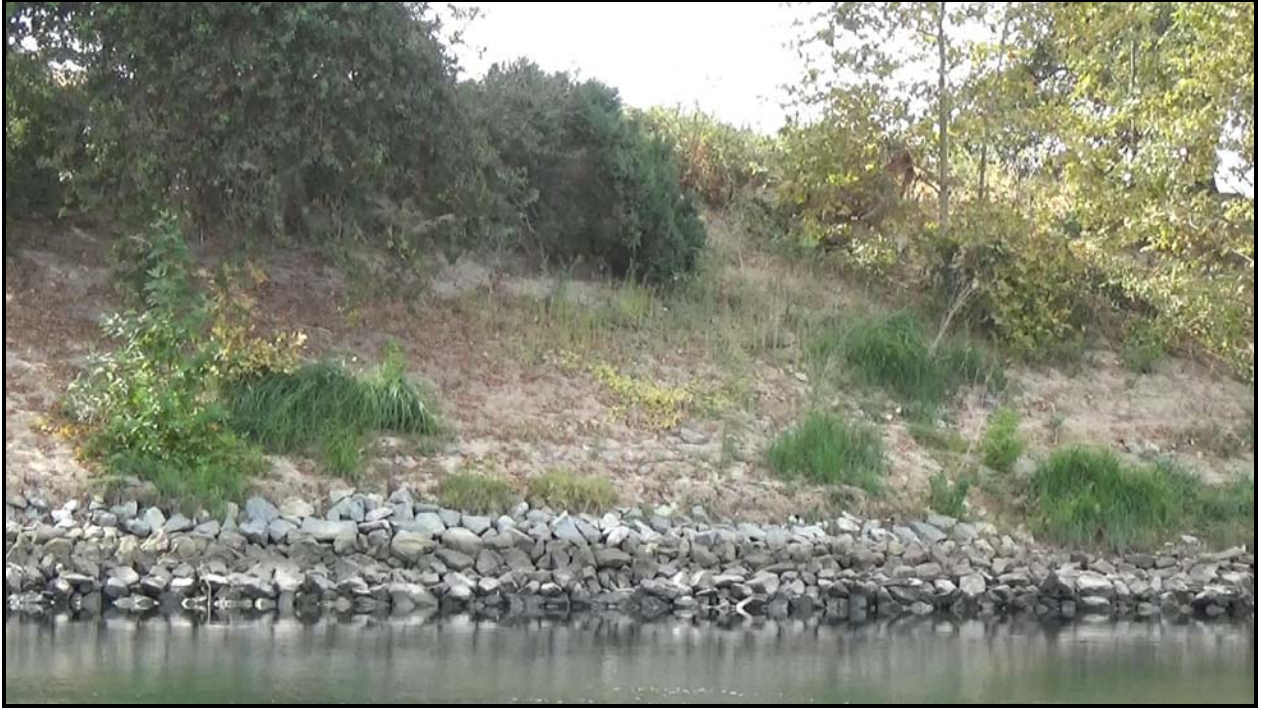
Photograph 23 - LAR RM 2.7L (2), repair site
