2017 Lower American River Streambank Erosion Monitoring Report

April 2018

Prepared for:
American River Flood Control District
&
Sacramento Area Flood Control Agency

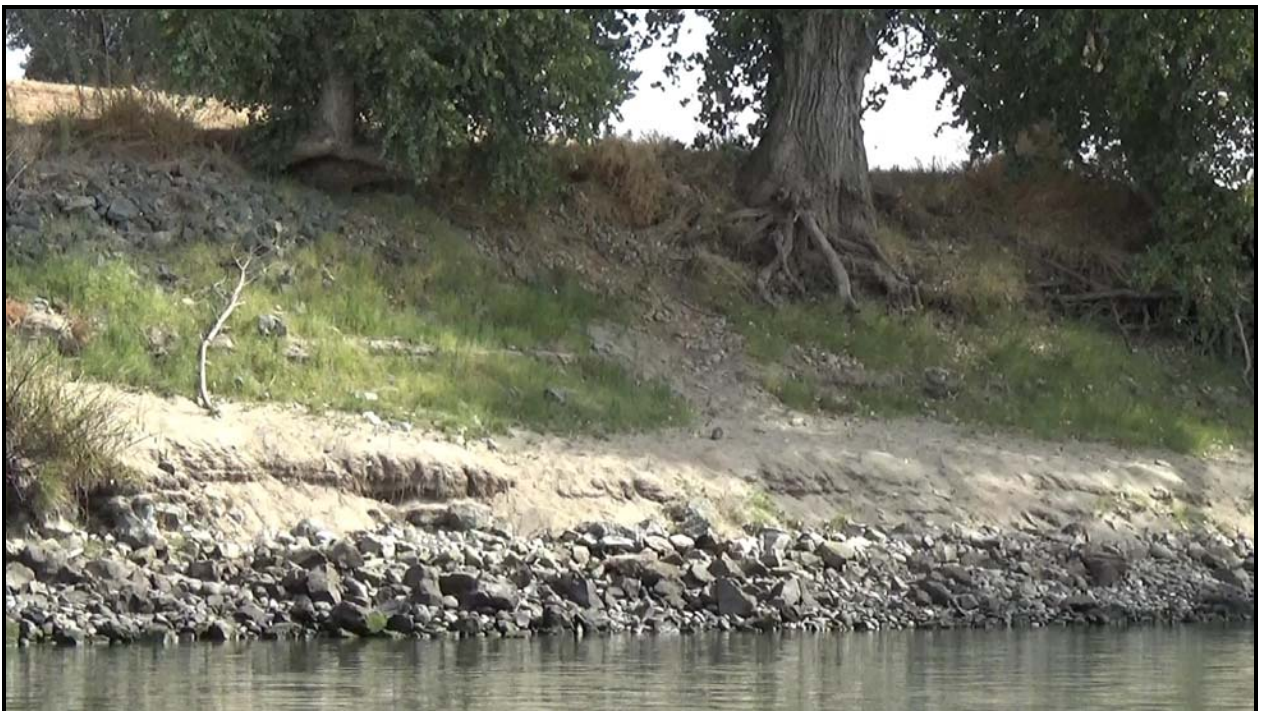
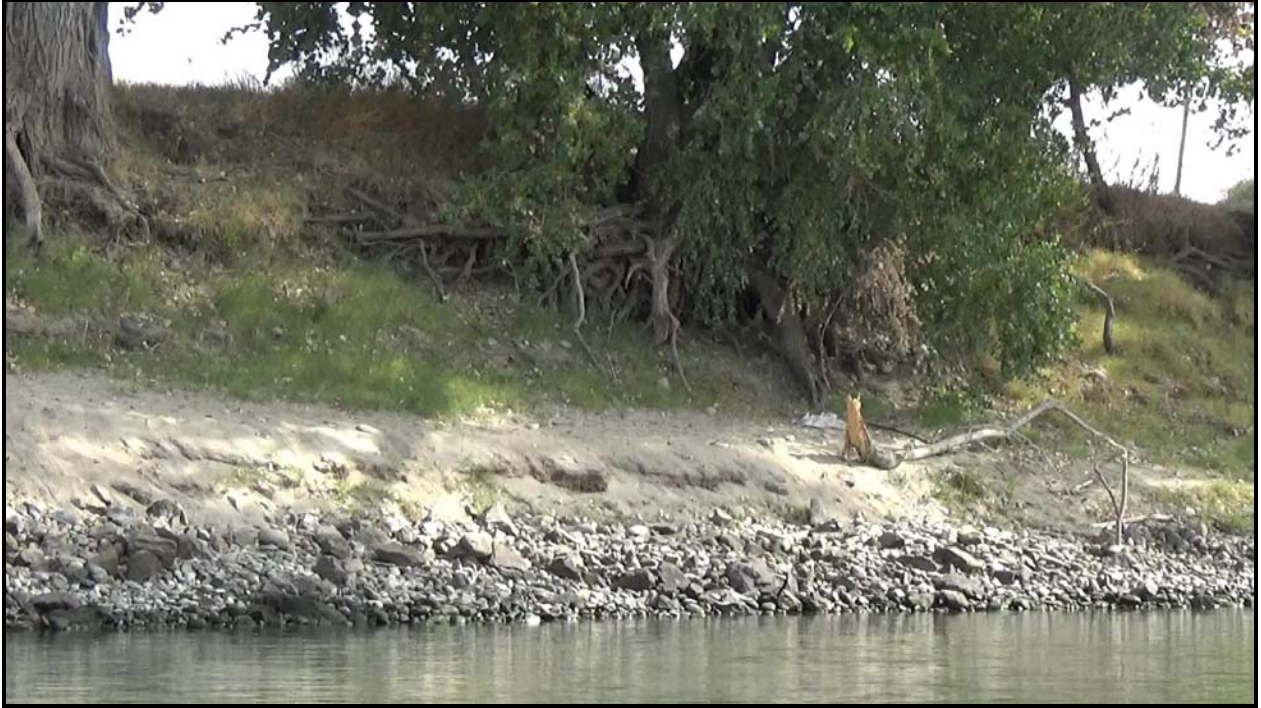
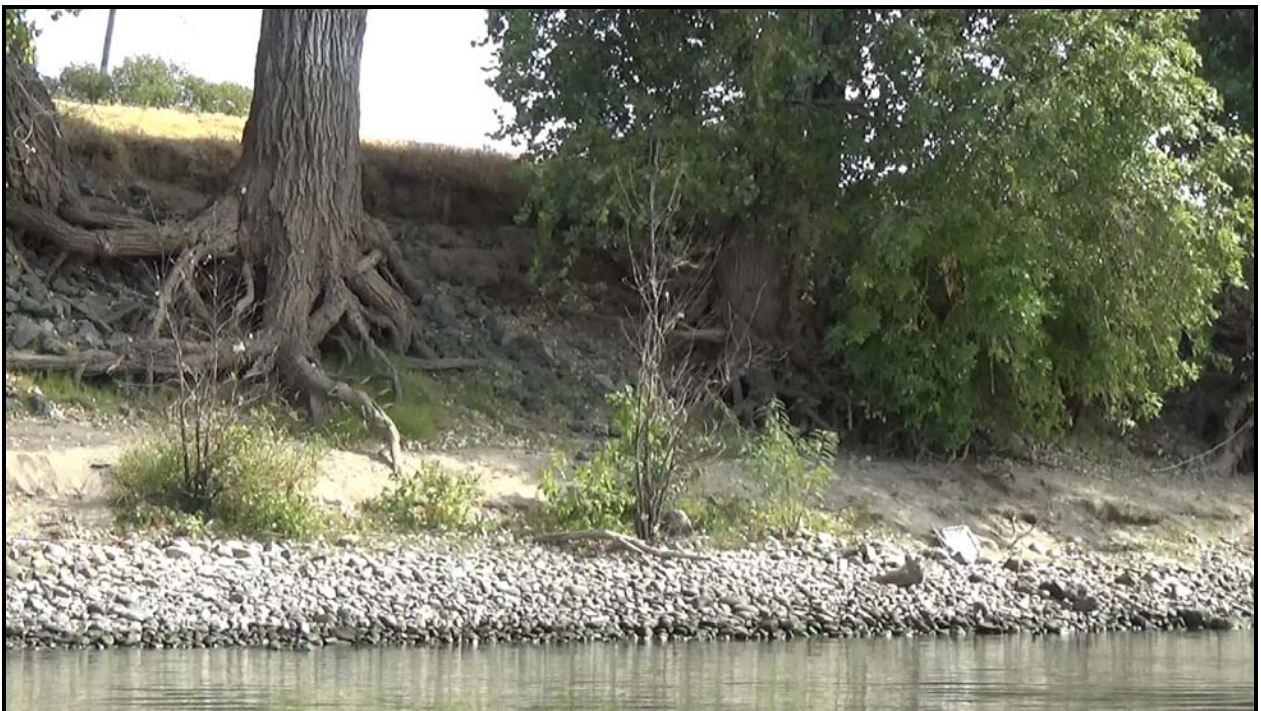
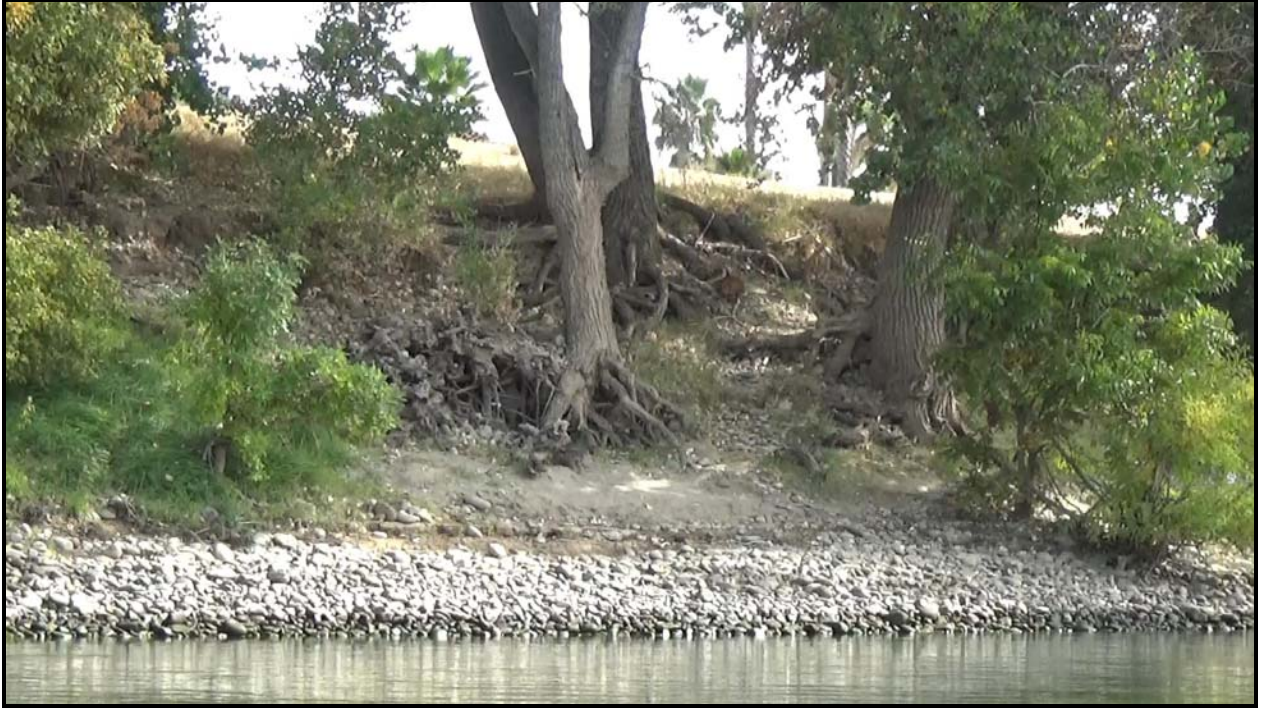
Sacramento River RM 60.3 Left – Recreational use is frequent at this site, contributing to the degradation of the embankment. Vegetative cover observed along the lower bank in 2016 is no longer present. Most of the trees along the levee slope have exposed roots. In 2013, one of the larger trees caught fire and fell over. The tree is no longer on the bank, but the void created by the uprooted portion of the tree is on the upper bank and the area should still be monitored to identify additional erosion or degradation, especially during and after rainfall. Overall, fill with vegetation on the upper bank is a possible solution to stabilize the bank. This site does not appear to represent an immediate threat to the levee based on the low velocities that characterize the reach; however, a more detailed site analysis could reveal that corrective action is required. The District has historically performed minor maintenance in the area to address erosion at the top of the slope. This site should continue to be monitored and maintained.

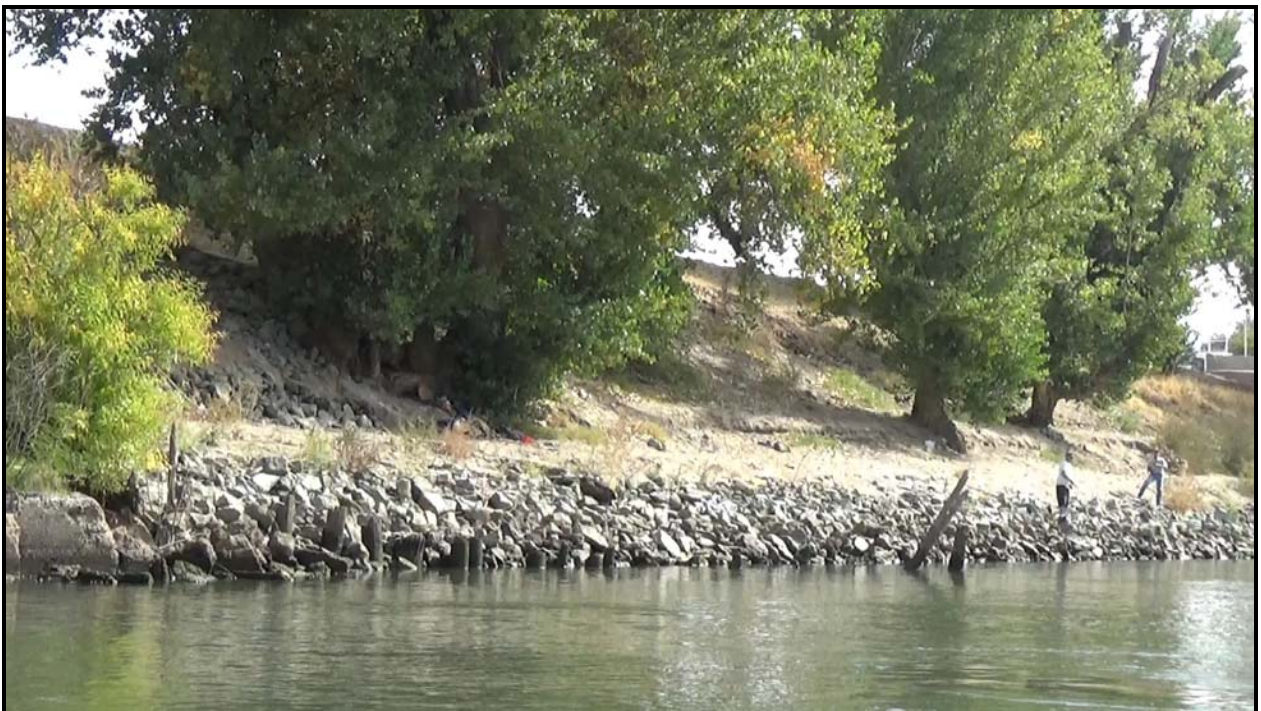
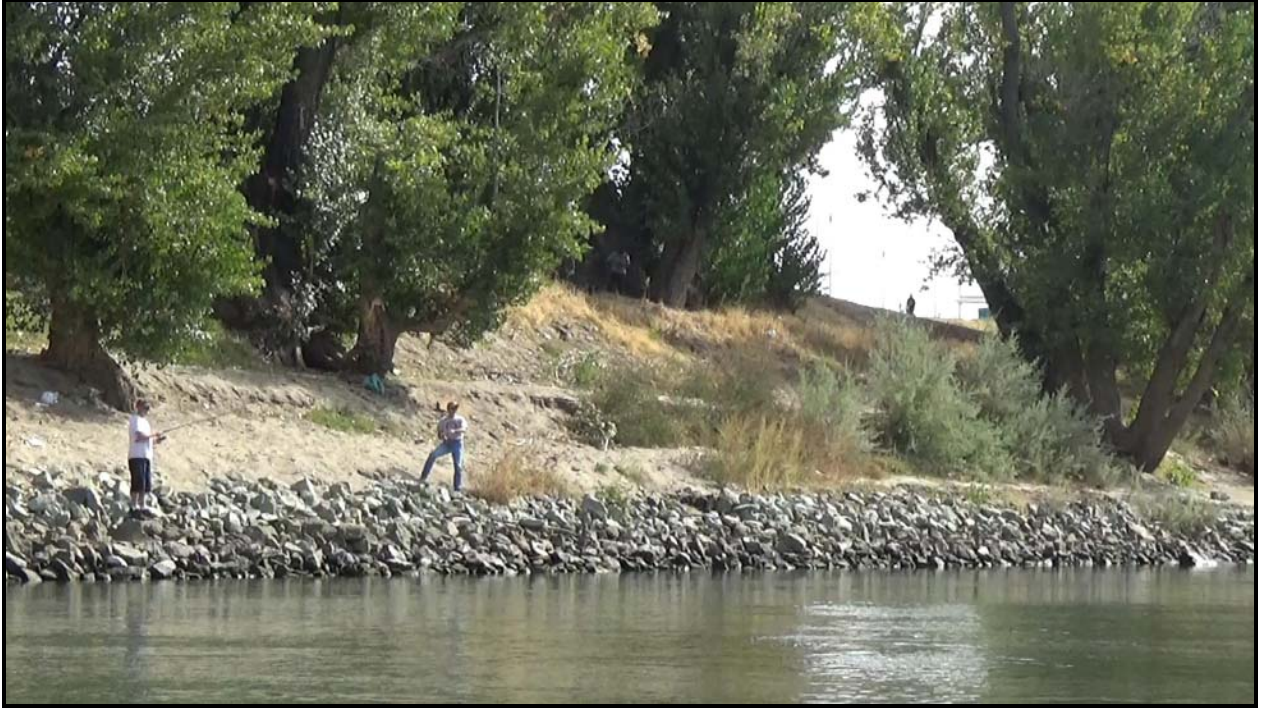
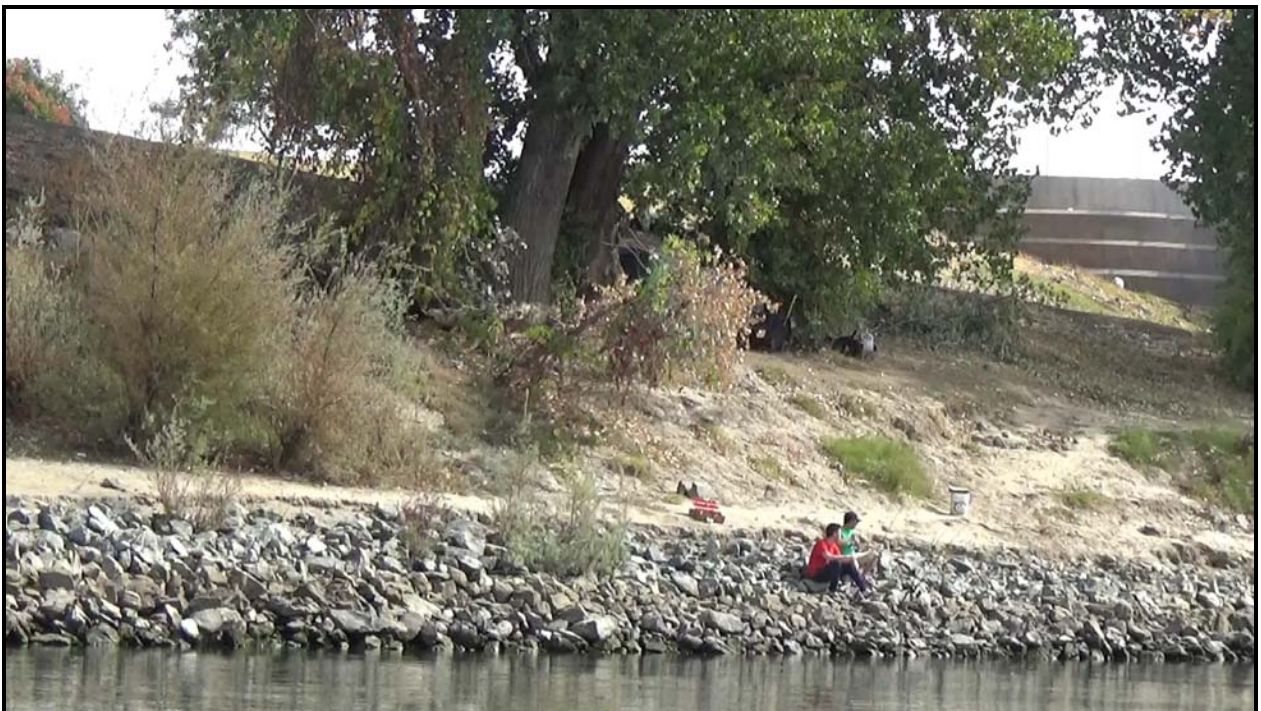
Sacramento River RM 60.1 Left – This site was repaired in October 2011. The site repair included a riprap bench established at the waterline to protect the bank from wind generated waves and boat wakes. Fill material was placed above the riprap to repair the eroded embankment. The site was hydroseeded in an effort to minimize future erosion. The willow trees that were planted in 2013 along the rebuilt slope remain intact. The original riprap and embankment repair appears to be holding up well and no further repairs are necessary at this time.

Sac River 60.1L	100 feet	2006	Site is between the old water intake facility and the new intake facility. Site was repaired in October 2011. Repaired levee appears to be in good condition.	>3 fps	>3 fps	Bike trail at top of bank. High recreational use.	In October 2011, a riprap bench was established at the waterline to protect the bank from wind generated waves and boat wakes. Fill material was placed above the riprap to repair the eroded embankment. The site was hydroseeded in an effort to minimize future erosion. Willows were planted above the riprap in 2013. Repair efforts have been successful and levee appears to be in good condition.
