# 2016 Lower American River Streambank Erosion Monitoring Report

**January 2017**

Prepared for:  
American River Flood Control District  
&  
Sacramento Area Flood Control Agency

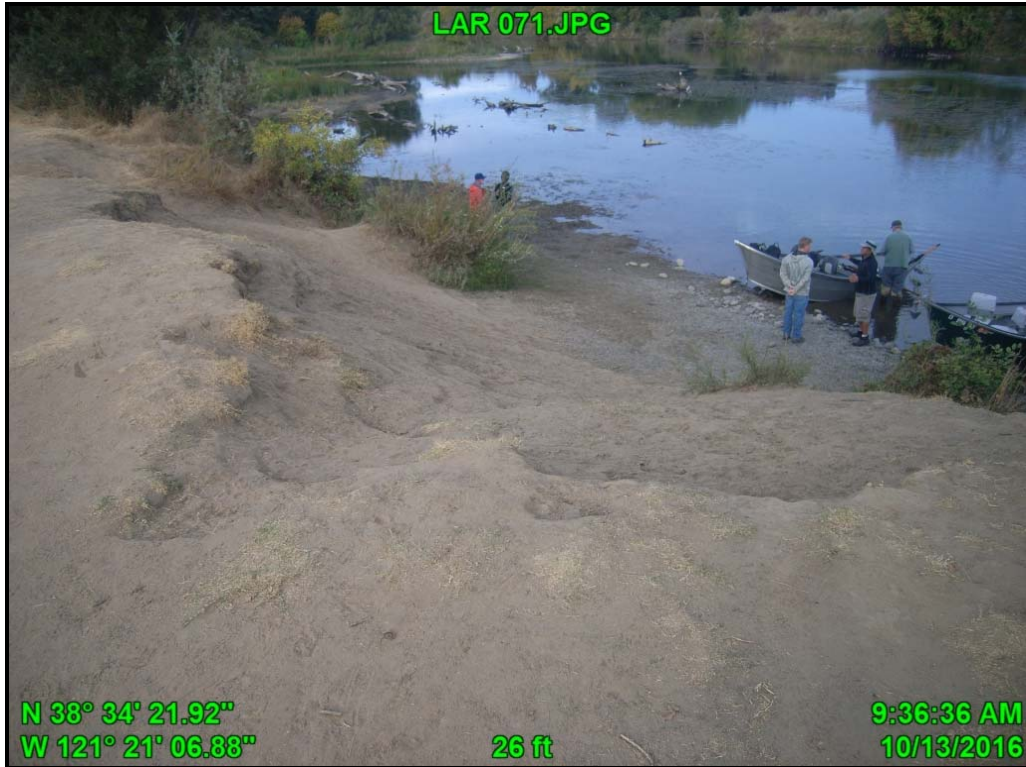
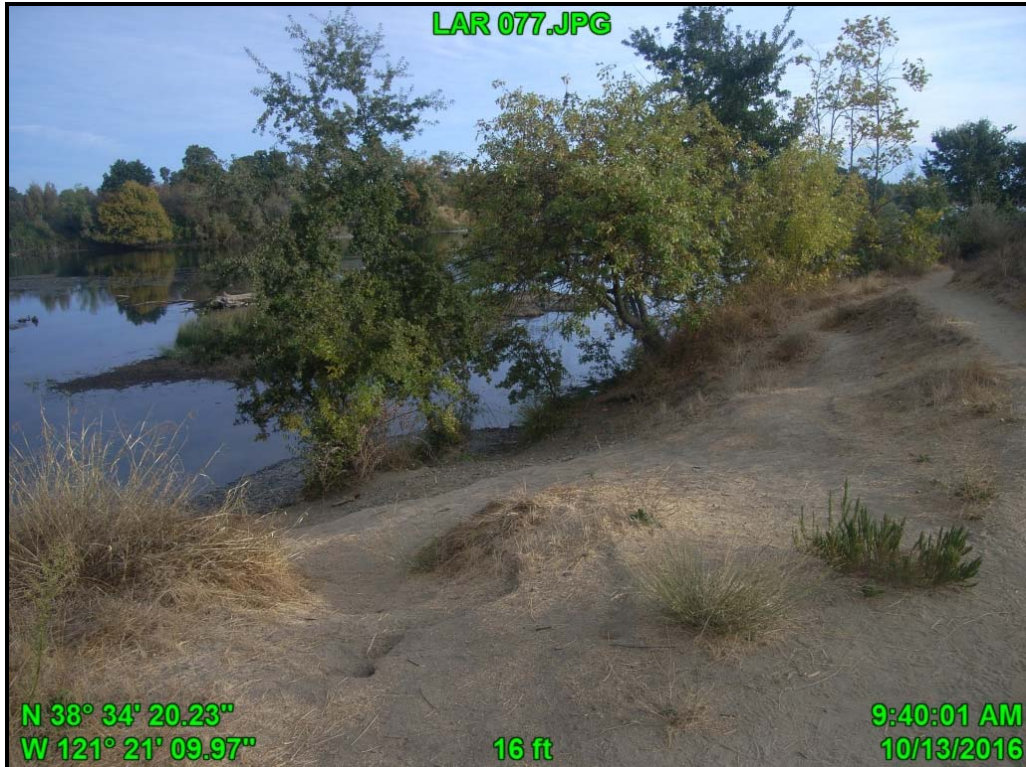
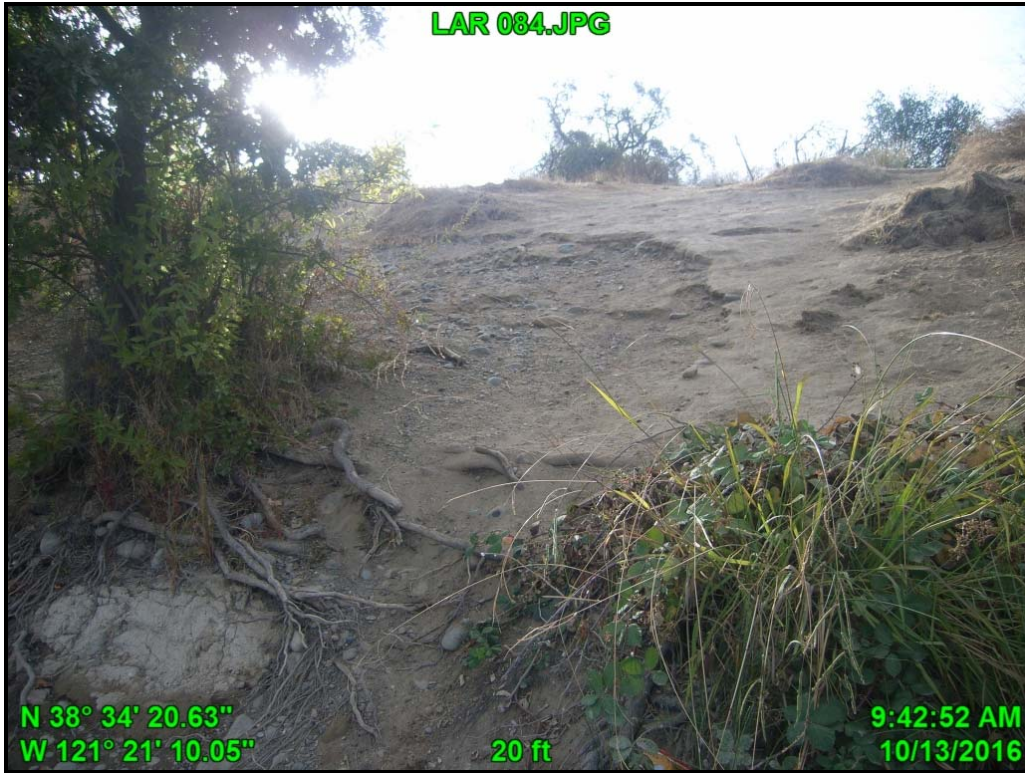
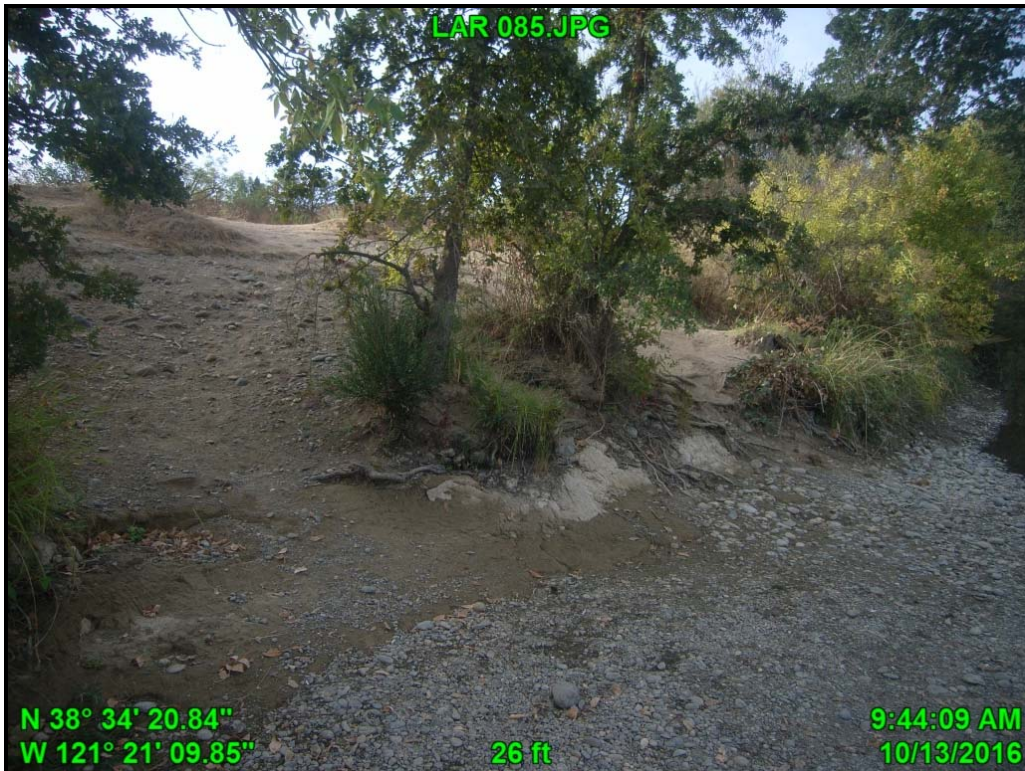
LAR RM 10.9 Left – Erosion at this site does not threaten the integrity of the levee due to the width of the berm. Planting woody vegetation on the bank would reduce the rate of erosion. However, recreational use at the site may dictate a more structural fix. Recreational use at the site appears to have slightly degraded portions of the upper bank since the 2015 inspection. Minor erosion was noted in 2010 in a confined area along the channel bank, likely due to animal activity and surface drainage. This erosion does not appear to have progressed significantly. Cross section surveys are an option that would enable the district to monitor the progression of the erosion at this site.

Site	Length	Year Identified	Conditions	Modeled Velocity	Modeled Velocity	Recreational Setting	Potential Action
River Mile				115,000 CFS	145,000 CFS		
10.9L	150 feet	2005	Poorly vegetated bank with 280 feet from channel to levee. Some minor erosion was first noted in 2010 in a confined area along the channel bank, likely a combination of animal activity and surface drainage. This erosion does not appear to have progressed significantly over the past several years. Minimal degradation observed along the upper bank since 2015 inspection.	1-3 fps	3-4 fps	Self-maintained walking trails at top of bank.	Establish woody vegetation thicket on bank or other biotechnical measures such as brush mattress, willow waddles or brush boxes (all supplemented with plantings), especially along waterside toe.

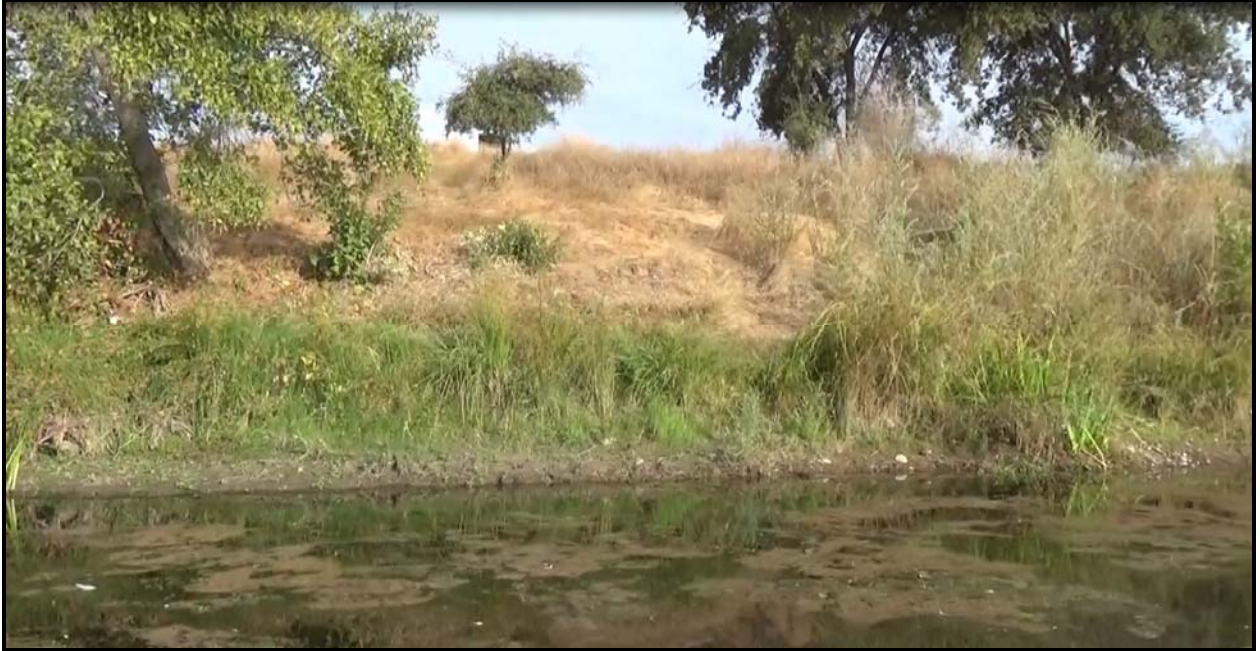
**Photograph 5 – LAR RM 10.8R**

LAR RM 10.8 Right – Erosion at this site does not threaten the integrity of the levee due to the width of the berm. Planting woody vegetation on the bank would reduce the rate of erosion. However, recreational use at the site may dictate a more structural fix. Minimal differences in site characteristics were observed as compared to the 2015 inspection.

10.8R	120 feet	2005	Minimal differences in site characteristics as compared to 2015 based on field inspection. Poorly vegetated, undercut bank with 175-foot berm to levee. Signs of recreational use are apparent at the site.	1-3 fps	1-3 fps	50 feet to Equestrian Trail and 85 feet to Bike Trail.	Establish woody vegetation thicket on bank or other biotechnical measures such as brush mattress, willow waddles or brush boxes (all supplemented with plantings), especially along waterside toe.

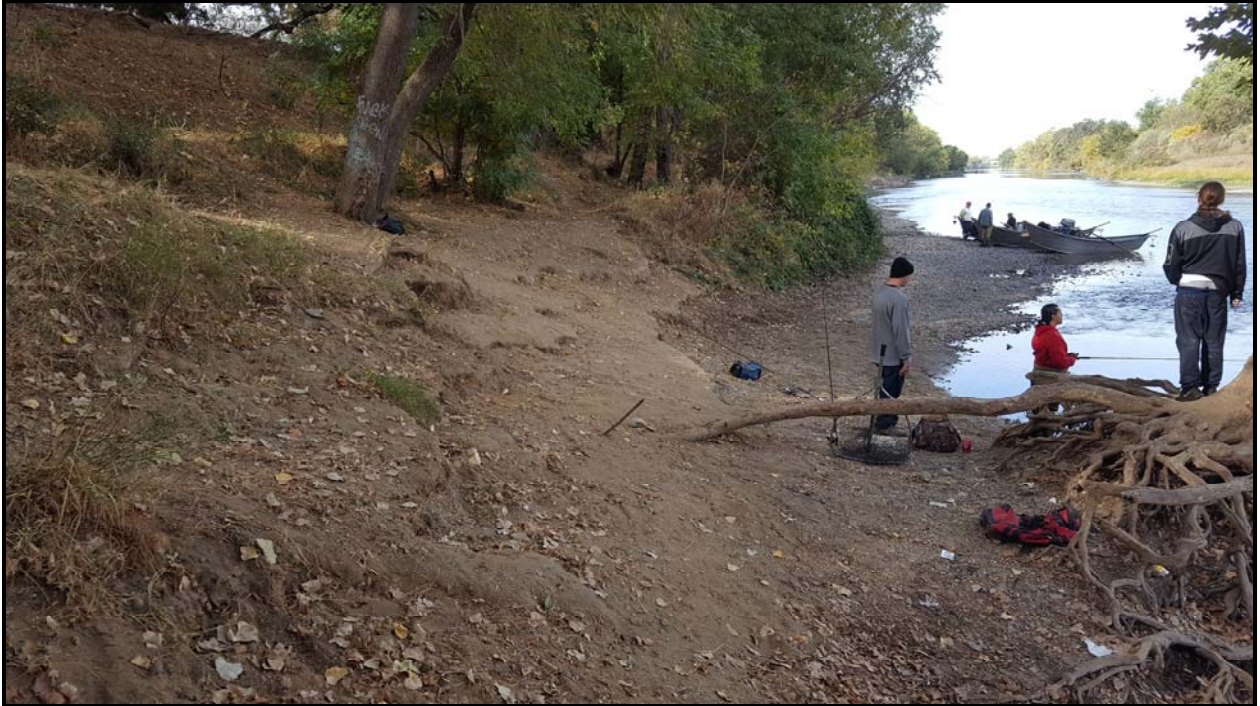
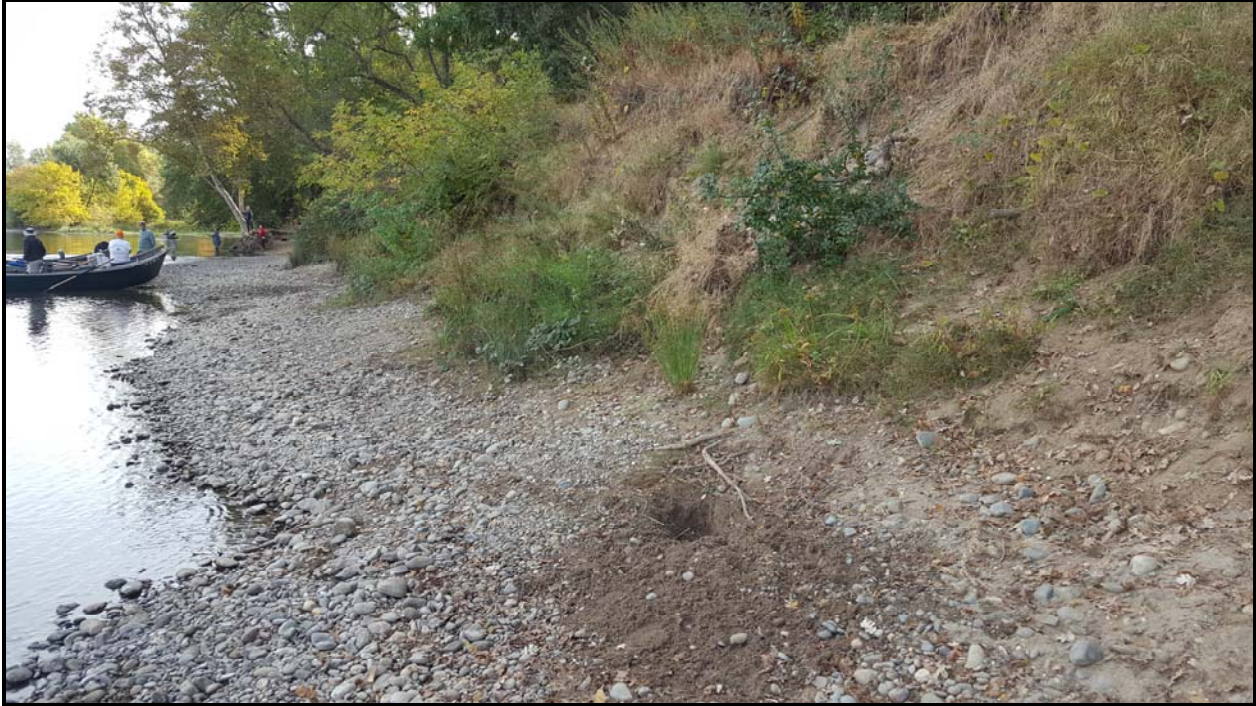
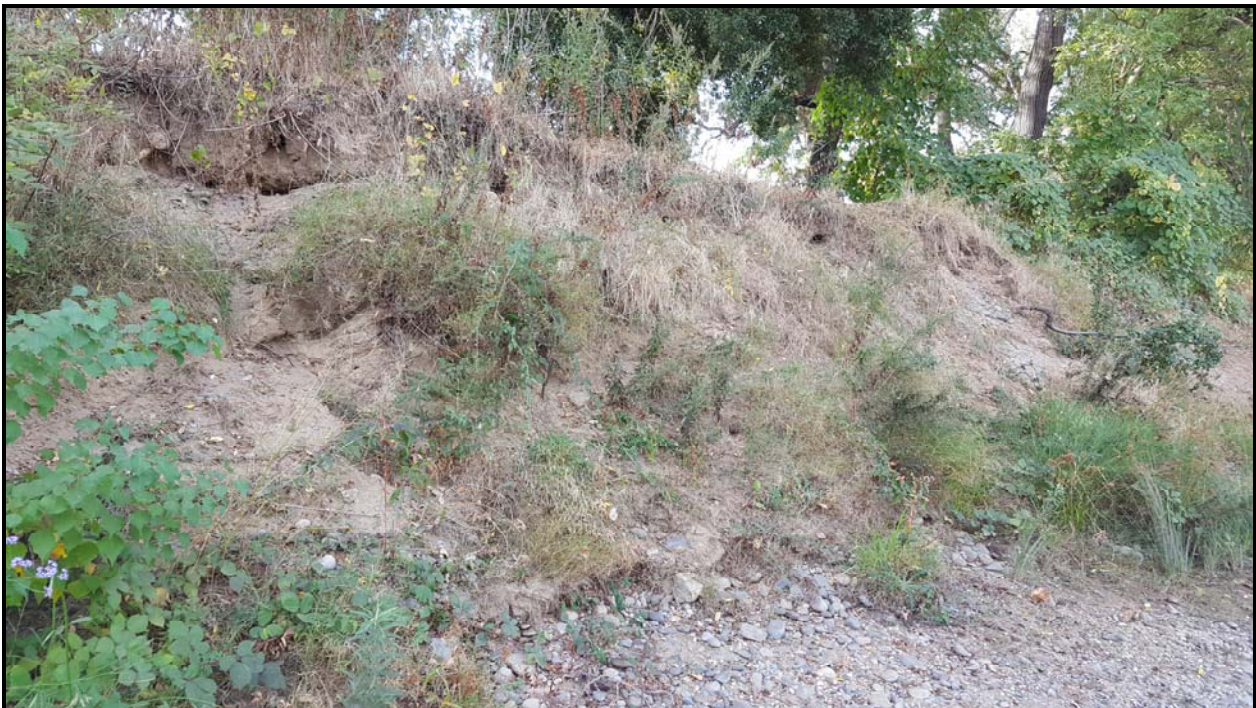
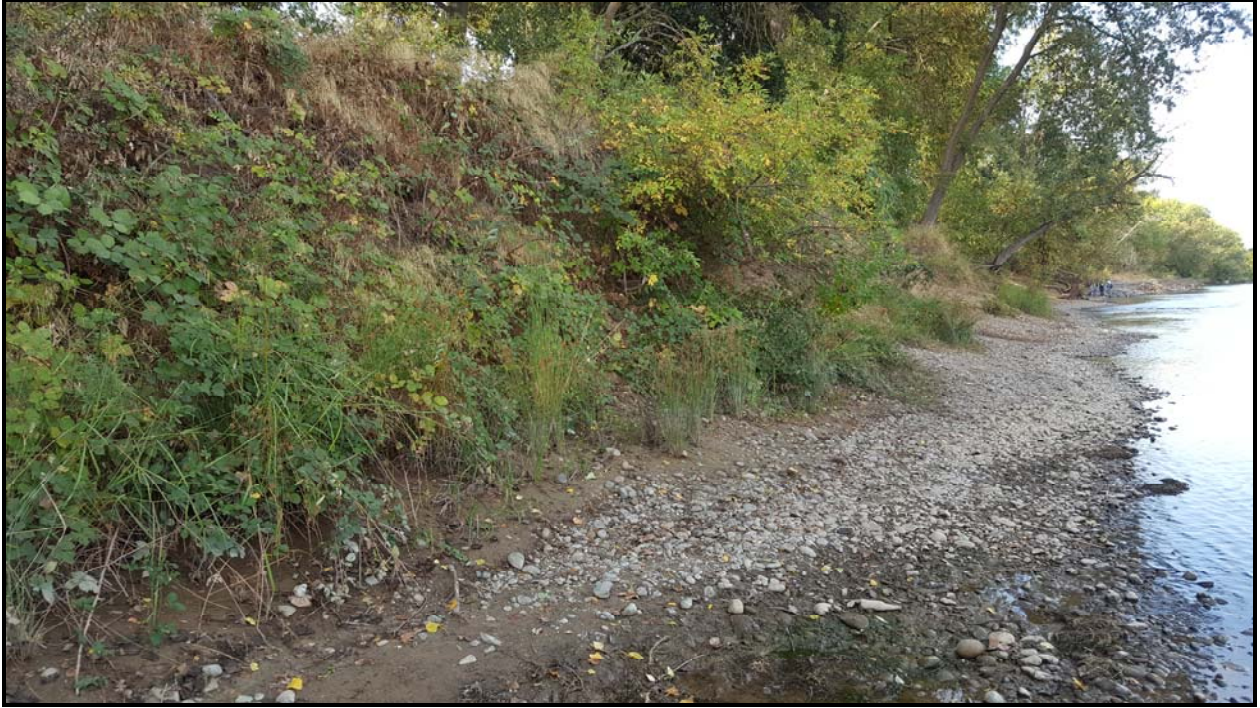
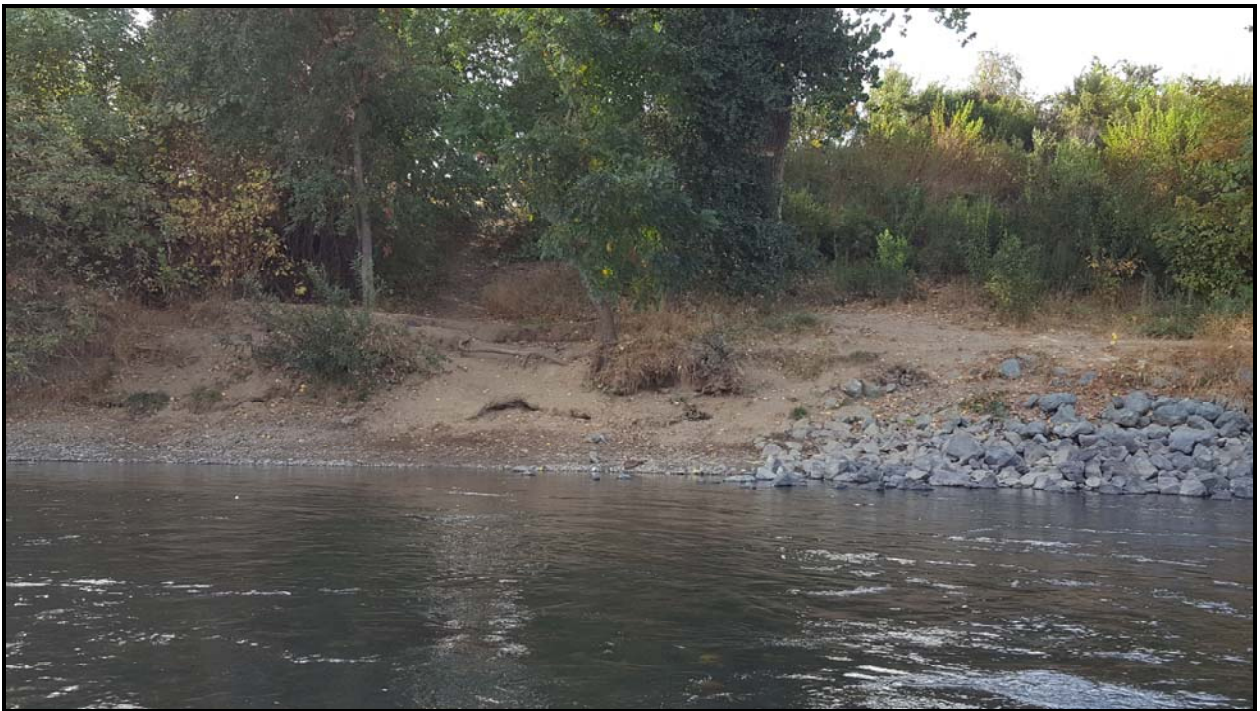
LAR RM 10.5 Left – Erosion at this site does not appear to threaten the integrity of the levee due to the width of the berm. However, the soils at the site appear to be non-cohesive soils that would likely erode rapidly during a high water event, especially if the vegetative cover continues to degrade due to high recreational use. Planting woody vegetation on the bank would reduce the rate of erosion. Recreational use at the site may dictate a more structural fix. Erosion at the upstream portion of the site does not appear to have progressed significantly since the 2015 inspection. A 20 foot section along the downstream end of the site shows signs of minor erosion. Since the 2015 inspection, additional rodent burrows have been observed along the steep middle and upper bank. If erosion continues to progress at the site, a more structural fix will be required. Repair of the site will need to accommodate intense recreational use.

The downstream portion of the site has been repaired by the US Army Corps of Engineers as part of the Sacramento River Bank Protection Program. Repairs included placing riprap along the bank as well as planting vegetation.

10.5L	150 feet	2006	Poorly vegetated bank with non-cohesive soils and heavy recreational use. Upstream portion of site has not degraded significantly since 2015 inspection. Small section (20 feet) along downstream end of site shows signs of minor erosion. Several rodent burrows were observed in the steep upper and middle bank. Downstream reach has been repaired by the Army Corps of Engineers under the Sacramento River Bank Protection Program.	1-3 fps	2-4 fps	Adjacent to Equestrian Trail and foot path.	Repair of the site will need to integrate recreational use. Due to the challenges with repairs at RM 10.0 (see 2006 report), vegetation is not likely to be successful due to the intense recreational use. Cobbles with vegetation or other biotechnical measures such as brush mattress, willow waddles or brush boxes (all supplemented with plantings) are a possible solution. The downstream reach has been repaired as part of the Sacramento River Bank Protection Project, also known as the Sac Bank Program.

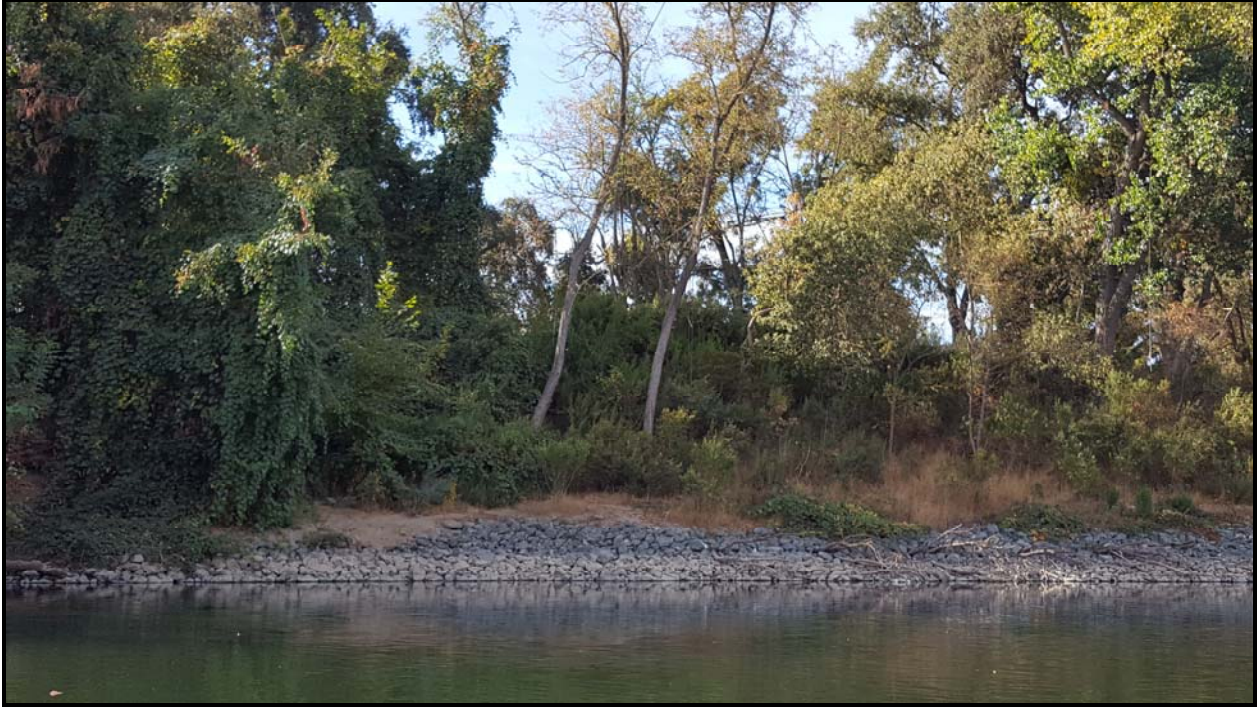
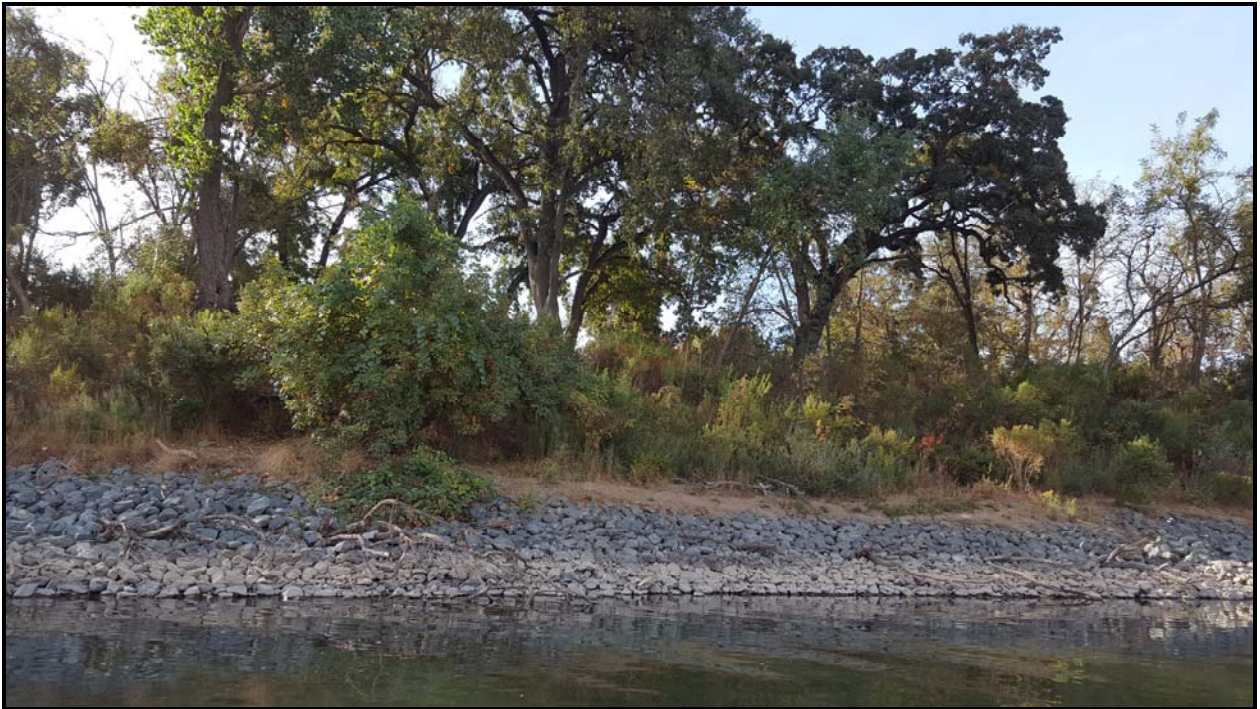
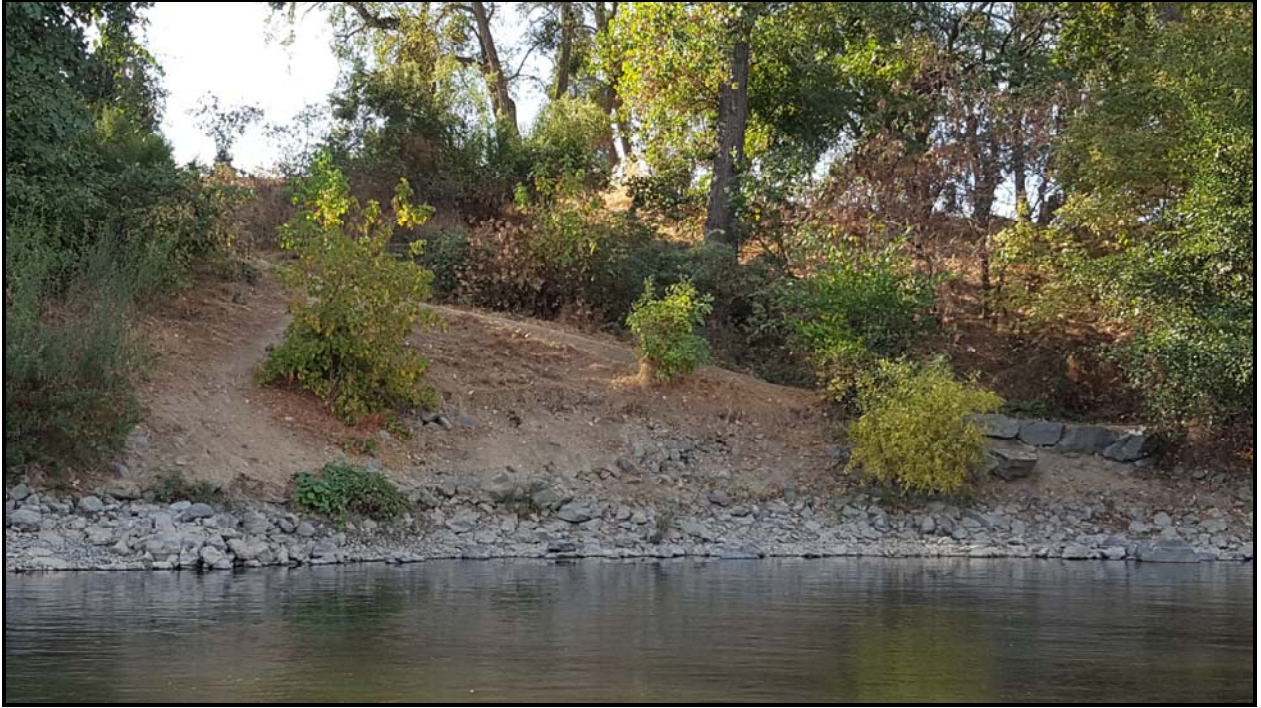
LAR RM 9.8 Left – This site has been repaired by the US Army Corps of Engineers as part of the Sacramento River Bank Protection Program. Construction activities included repairing the eroded sections of the site by placing riprap along the bank as well as planting vegetation.

The west end of this site (downstream, formerly known as Site 10.0L) was previously repaired and woody vegetation was planted on the waterside edge of the berm. This planting appears to have reduced the rate of erosion as it has not progressed significantly since 2015. Observations indicate the cobble and the finer particles on the surface of the berm continue to erode, exposing some of the underlying riprap. This appears to be the result from primarily pedestrian and recreational activity. However, this condition is largely aesthetic and the structural component appears to be intact. The repair appears to be holding up relatively well, however it is highly correlated to the amount of pedestrian use at the site. The District has historically performed minor maintenance in the area to stabilize the pedestrian path.

9.8L	1150 feet	2005	Erosion has historically occurred due to high pedestrian access / recreational use, however it does not appear to have progressed significantly since 2015. The upstream reach has been repaired by the Army Corps of Engineers under the Sacramento River Bank Protection Program.	4-6 fps	5-7 fps	65 feet to levee maintenance road	The upstream reach has been repaired as part of the Sacramento River Bank Protection Project, also known as the Sac Bank Program. The downstream reach was previously repaired and appears to be holding up relatively well.

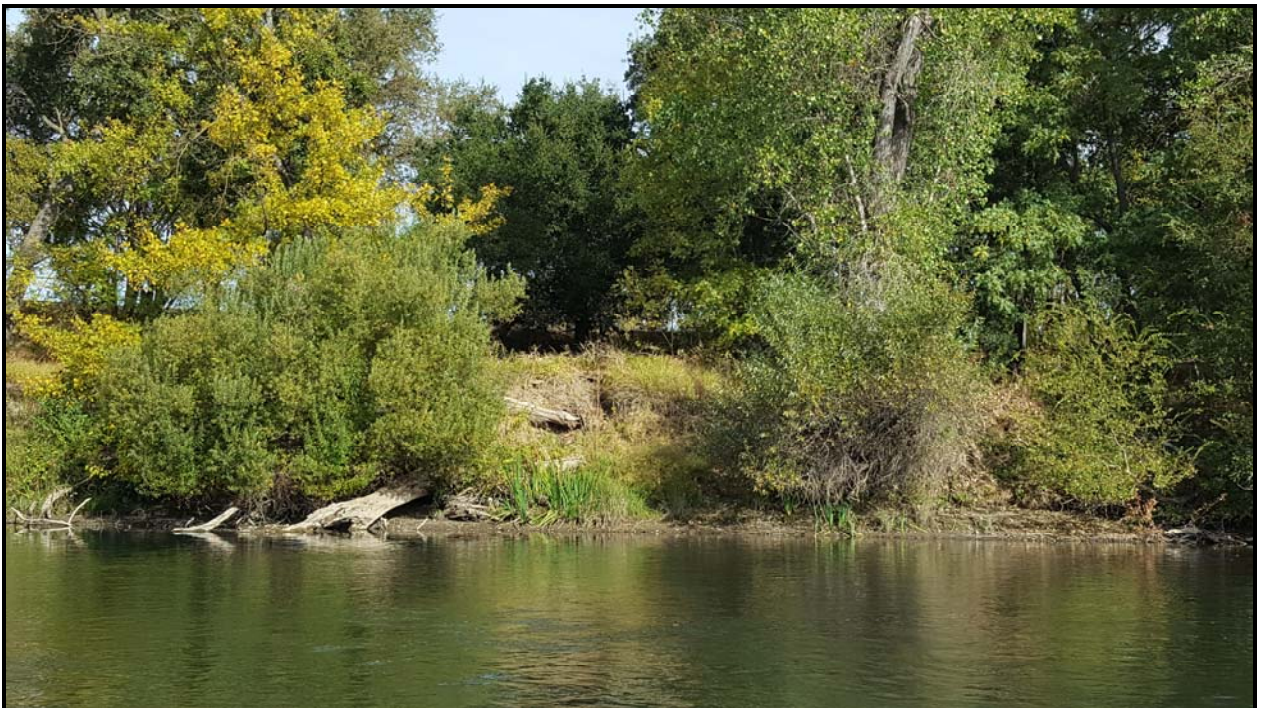
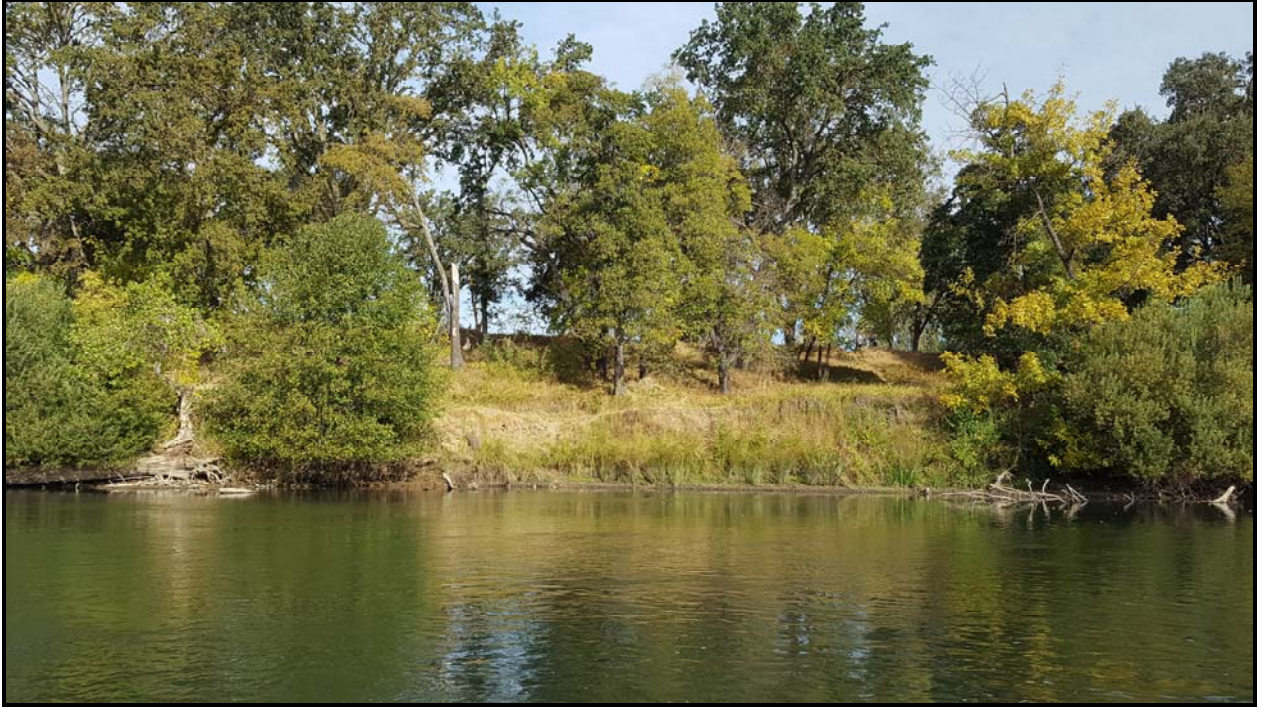
LAR RM 8.8 Right – This site was previously studied by the Sacramento River Bank Protection

Project as the “Site 5 extension” (Lower American River – Site 5 Extension, US Army Corps of Engineers, prepared by HDR, March 2002). Consideration should be given to repairing the scalloping at this site to reduce the rate of erosion. Consideration should also be given to taking action over the entire reach to preserve the berm, equestrian trail, and existing mature vegetation. No visible progression of erosion or undercutting on vertical banks was observed during the inspection, and it should be noted that the vegetation cover appears to be similar to the 2015 inspection. Due to the high level of recreational activity at this site, a cross section survey of the entire reach was performed by MBK in March 2013. Subsequent surveys could be performed as needed to monitor the rate of erosion and degradation of the bank.

8.8R	280 feet	2005	Undercut, vertical bank sloughing into river, 100 foot berm to levee. Vegetative cover is similar to 2015. Undercutting along vertical banks does not extend below water level.	3-5 fps	4-6 fps	Adjacent to Equestrian Trail ; 60 feet to Bike Trail.	Armor bank at and below low flow shoreline with rock and treat upper bank with biotechnical measures such as brush mattress, willow waddles or brush boxes (all supplemented with plantings). Cross section survey was performed by MBK in March 2013 to monitor erosion and degradation of bank.

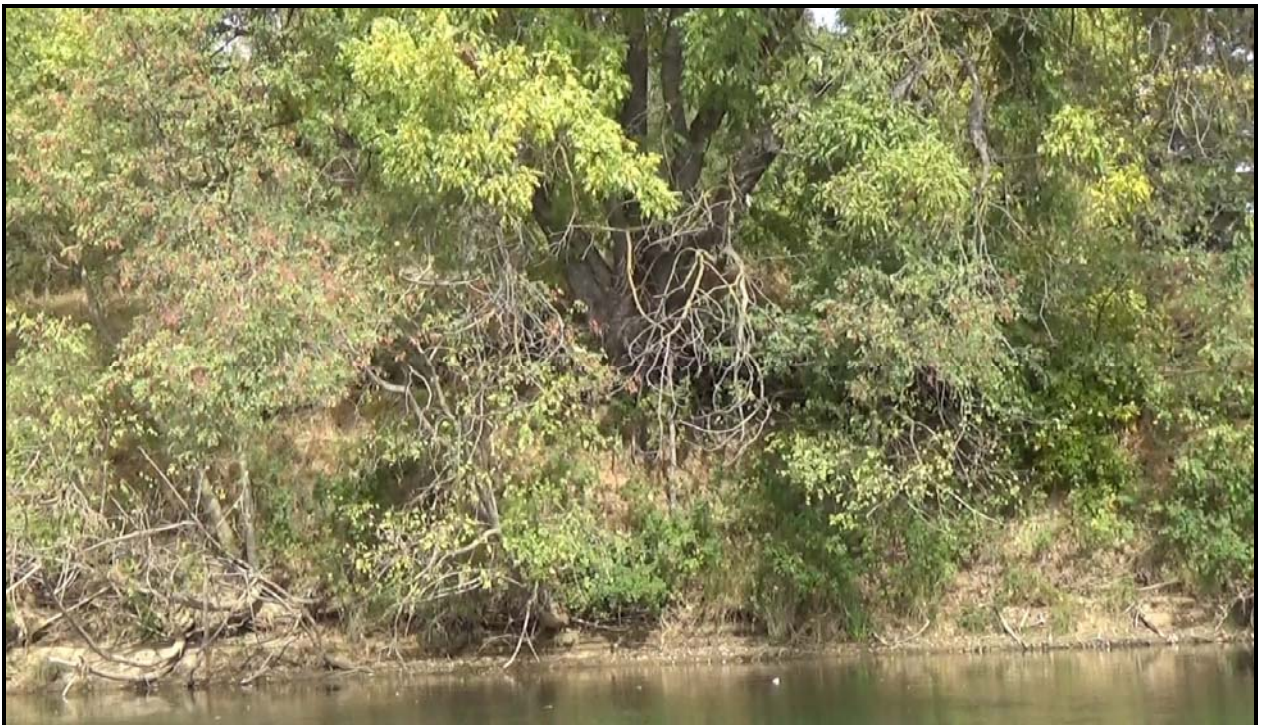
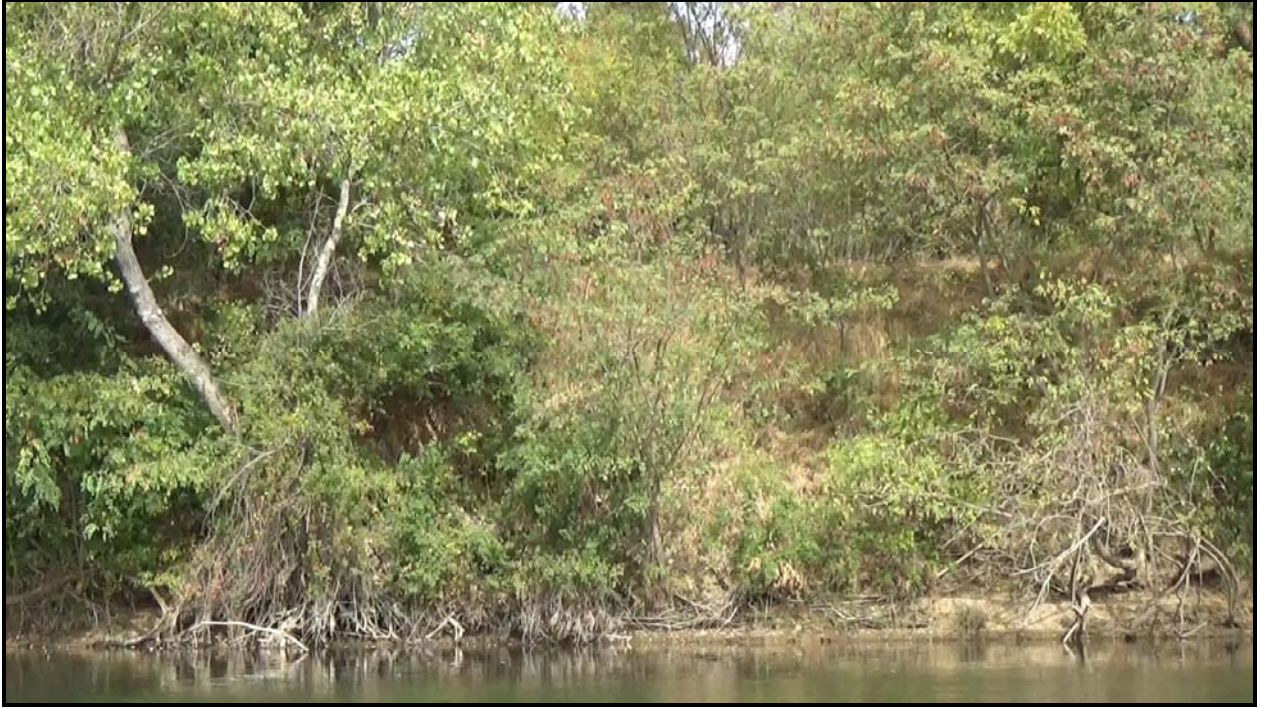
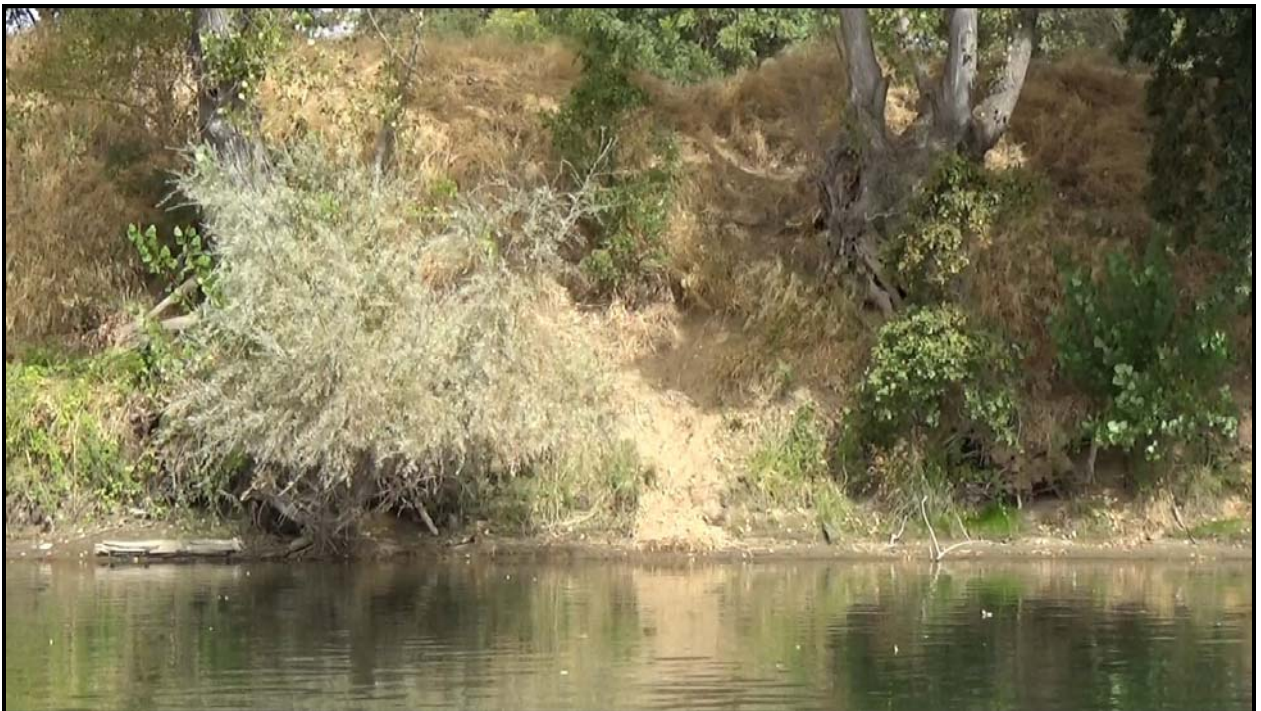
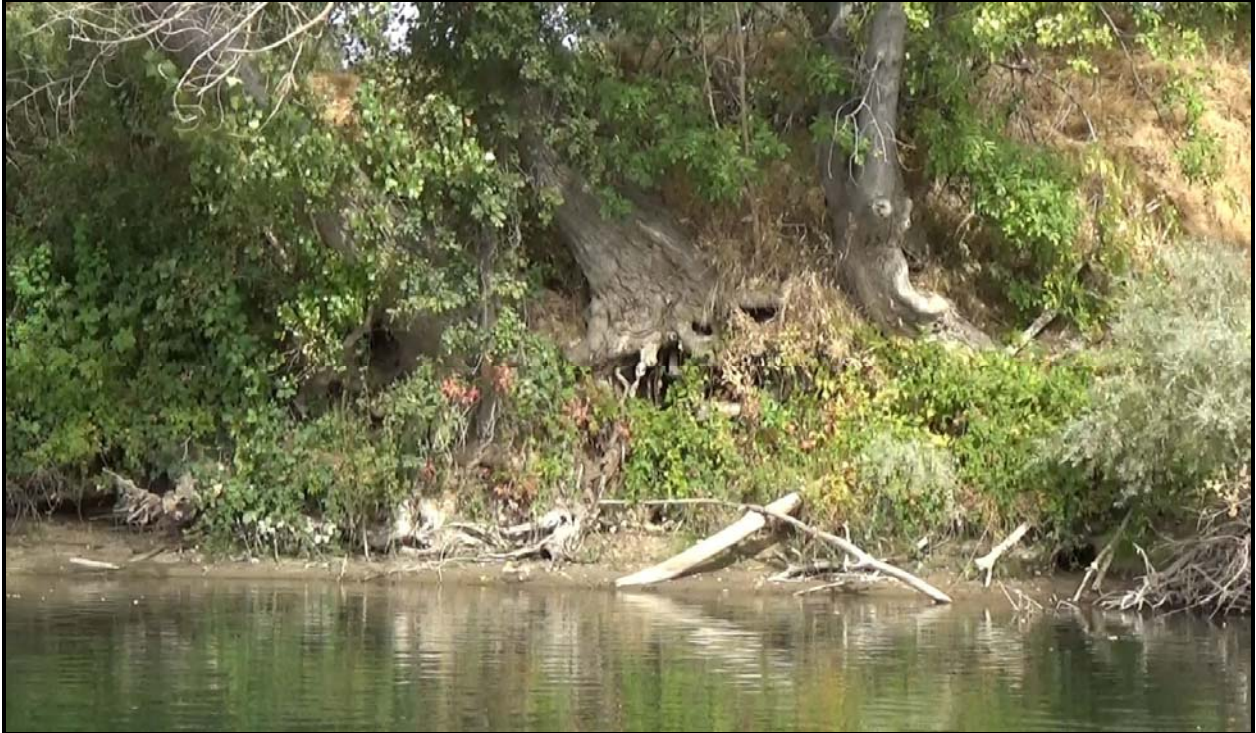
LAR RM 7.5 Right – Erosion at this site does not threaten the integrity of the levee due to the width of the berm. Planting woody vegetation on the bank may reduce the rate of erosion and should be considered. The width of the berm is substantial (greater than 100 feet) at this site. However, the apparent erodability of the exposed soils could lead to significant erosion during a high flow event, although it is not anticipated to erode the entire berm in one flood event. Armoring the bank with biotechnical measures such as brush mattress, willow waddles or brush boxes (all supplemented with plantings) should be considered to preserve the berm and bike trail. Erosion at this site does not appear to have progressed since the 2015 inspection. Vegetative cover also appears to be similar to 2015.

7.5R	820 feet	2005	No visible progression of erosion compared to 2015 field inspection. Undercut, vertical bank sloughing into river, 150 foot berm to levee. Vegetative cover is similar to 2015.	3-6 fps	5-6 fps	40 feet to Equestrian Trail; 80 feet to Bike Trail.	Restore slope and armor bank.

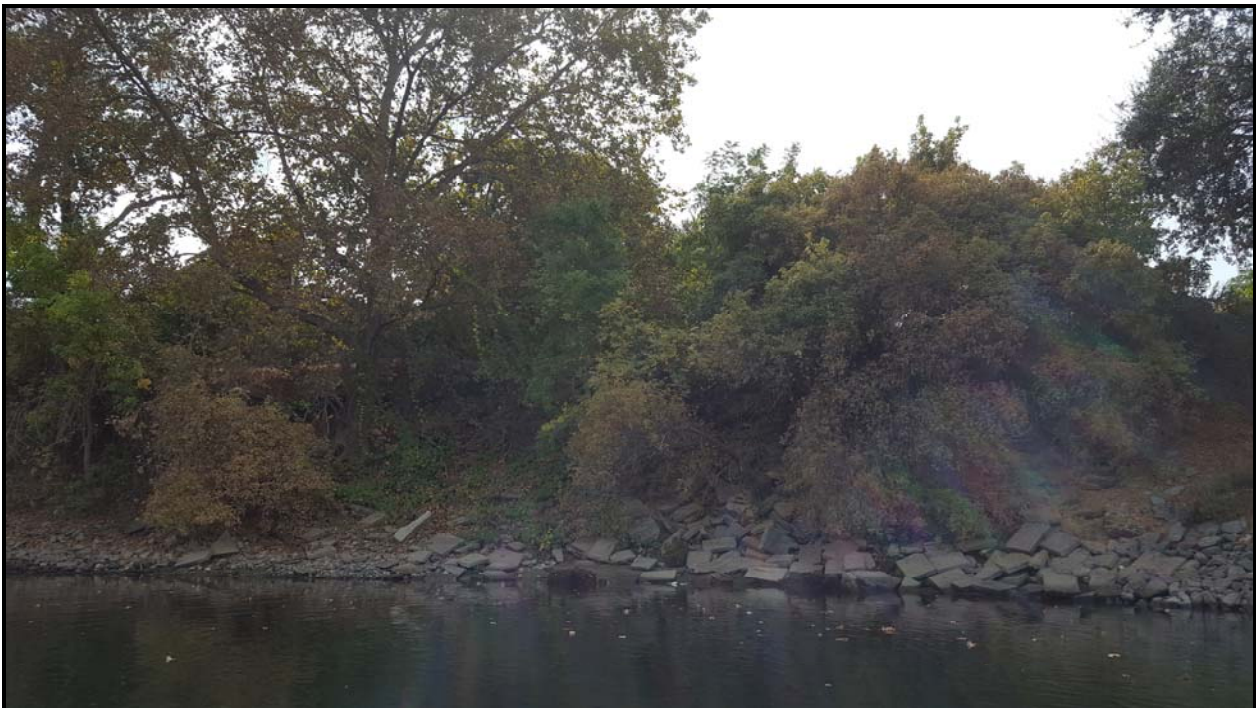
LAR RM 2.7 Left – This site has been partially repaired by the Army Corps of Engineers under the Sacramento River Bank Protection Program. As previously noted, it was observed that the repair efforts do not appear to encompass the entire area experiencing erosion, specifically the upstream portion of the site. Erosion at the upstream end of the site threatens the integrity of the floodwall because the streambank is steeper than 3:1. This floodwall has been previously studied by MBK (Alternatives Analysis for Replacement of the Existing Floodwall at Lower American River, River Mile 2.7, March 2007). This report concluded that a failure of the wall at or below flows of 160,000 cfs would lead to localized flooding, as shown in Figure 3, because flooding would be contained by high ground that surrounds the wall. However, so long as this floodwall is an element of the Sacramento River Flood Control Project, the integrity of the floodwall should be maintained. This site does not appear to represent an immediate threat to public safety because of high ground located behind the levee and floodwall; however, a more detailed site analysis could be performed to determine if corrective action is required.

2.7L	700 feet	2006	Site has been partially repaired by the Army Corps of Engineers under the Sacramento River Bank Protection Program. Repair efforts do not appear to encompass all areas experiencing erosion, specifically the upstream end of the site.	1-3 fps	2-4 fps	Private property, limited public access.	Extend the repair efforts further upstream to include the erosion near the existing floodwall (approximately 350 feet).
Sac River 60.3L	330 feet	2006	Site is north of the old water intake facility. Streambank above waterline is over steepened with poorly vegetated bank and non-cohesive soils. Erosion historically has migrated toward the access road on the bench. The District has historically performed minor maintenance in the area to address erosion at the top of the slope. Most trees along levee slope have exposed roots. The large tree on the upper slope that caught fire and fell towards the river in 2013 is no longer on the bank, but the void from the root wad remains on the upper bank.	>3 fps	>3 fps	Bike trail at top of bank. High recreational use.	Fill with vegetation or biotechnical measures such as brush mattress, willow waddles or brush boxes (all supplemented with plantings). Site (including void created by uprooted portion of tree) should continue to be monitored and maintained, especially during and after rainfall.

**Photograph 20 - LAR RM 2.7L (1), upstream of repair site**

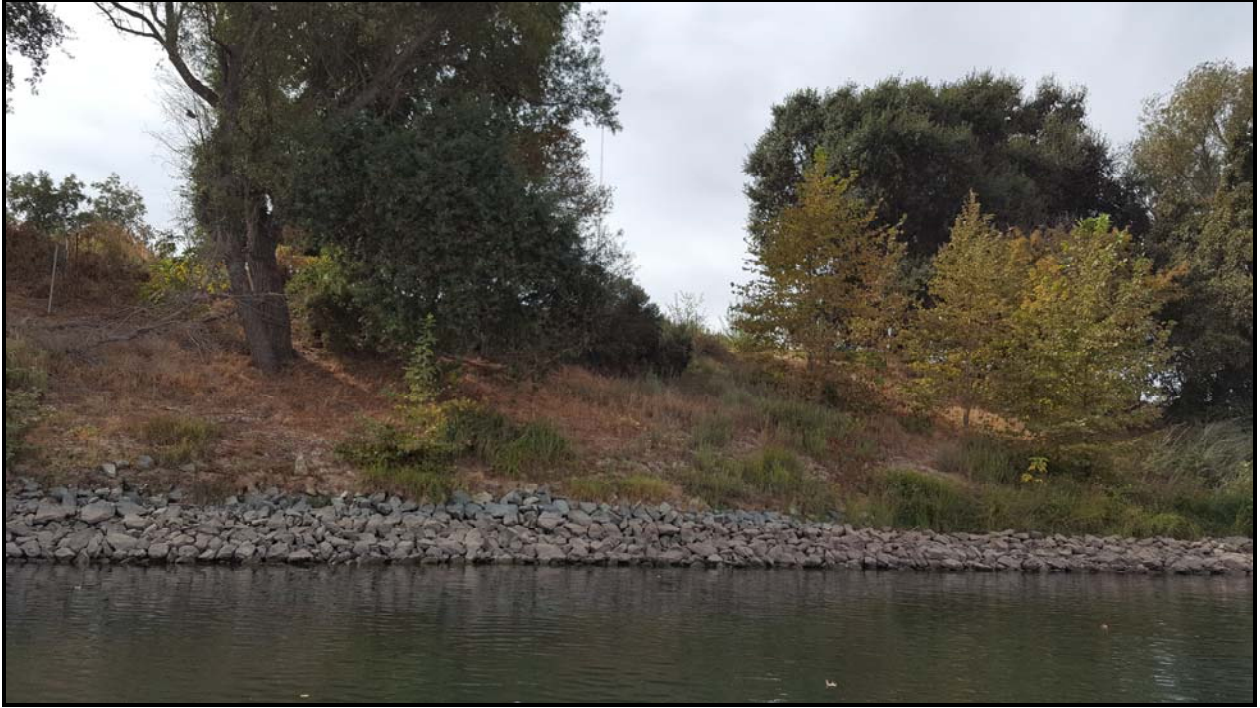
**Photograph 21 - LAR RM 2.7L (2), repair site**
