# 2016 Lower American River Streambank Erosion Monitoring Report

**January 2017**

Prepared for:  
American River Flood Control District  
&  
Sacramento Area Flood Control Agency

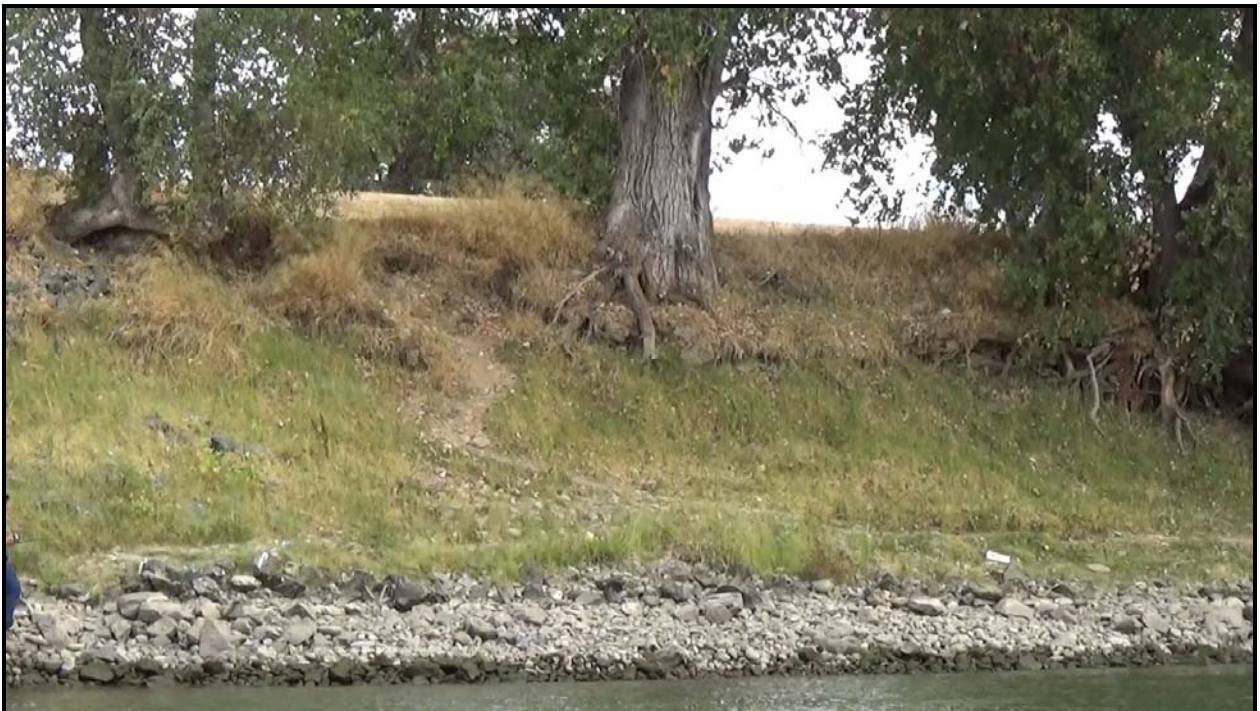
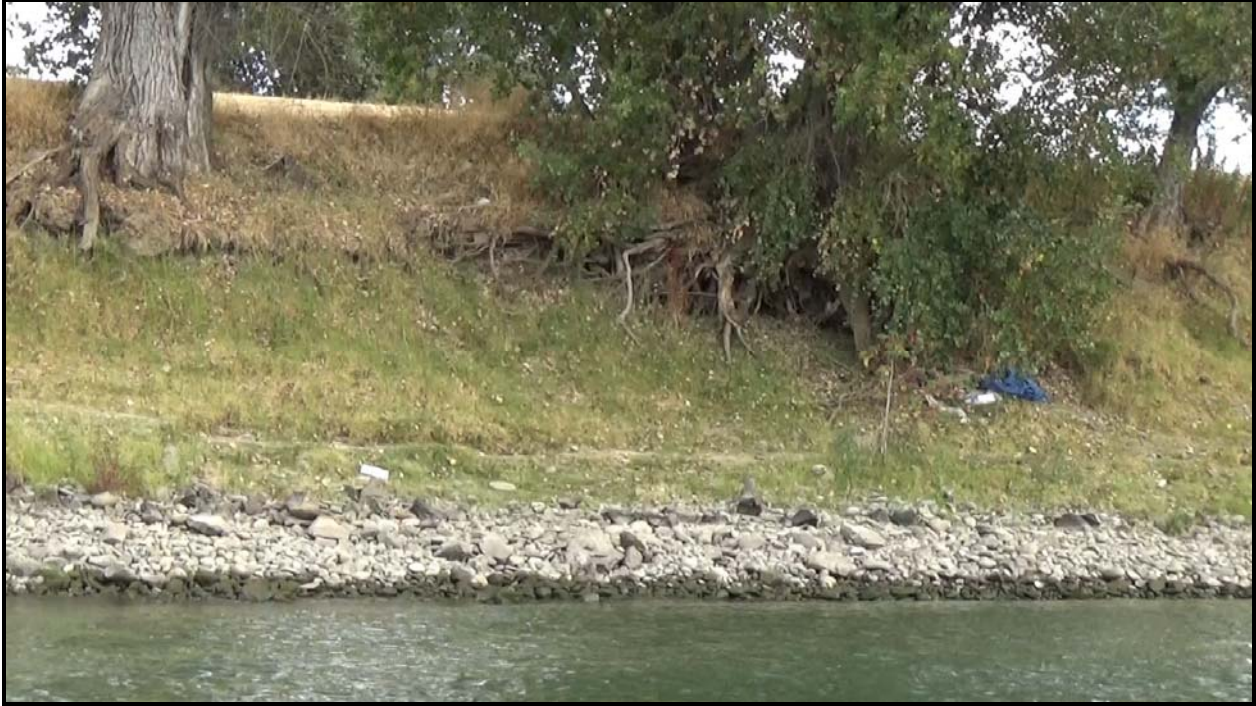
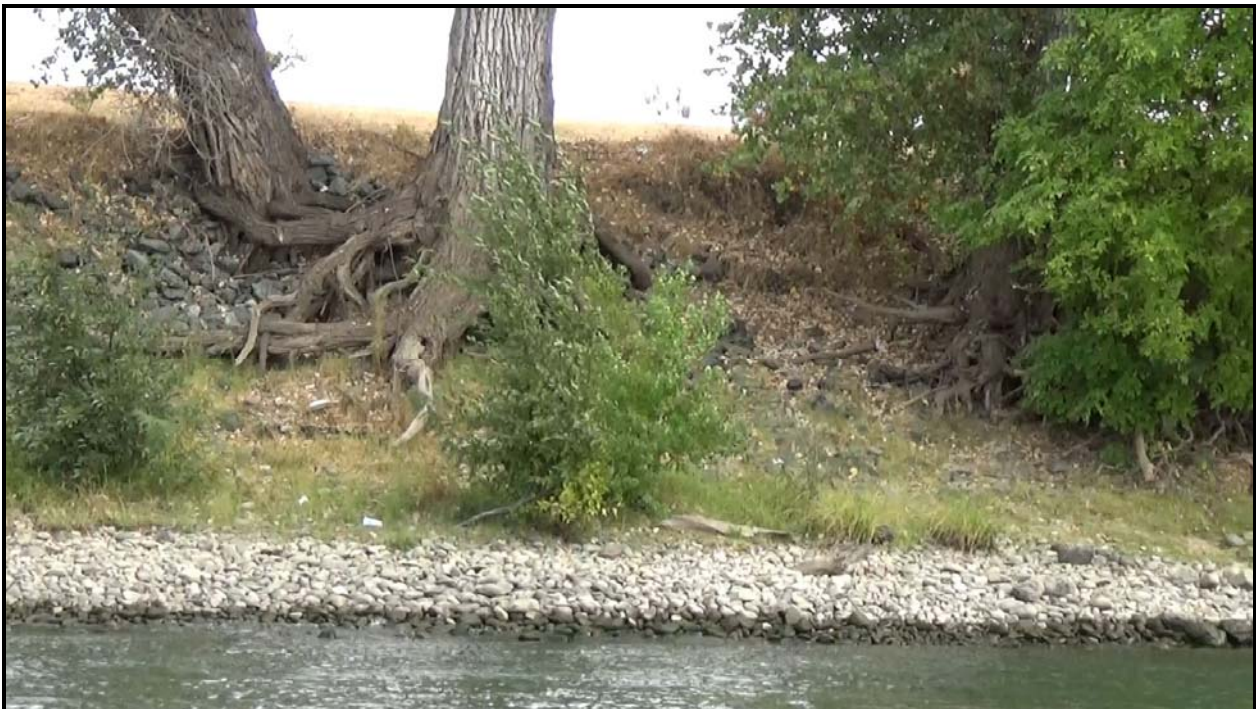
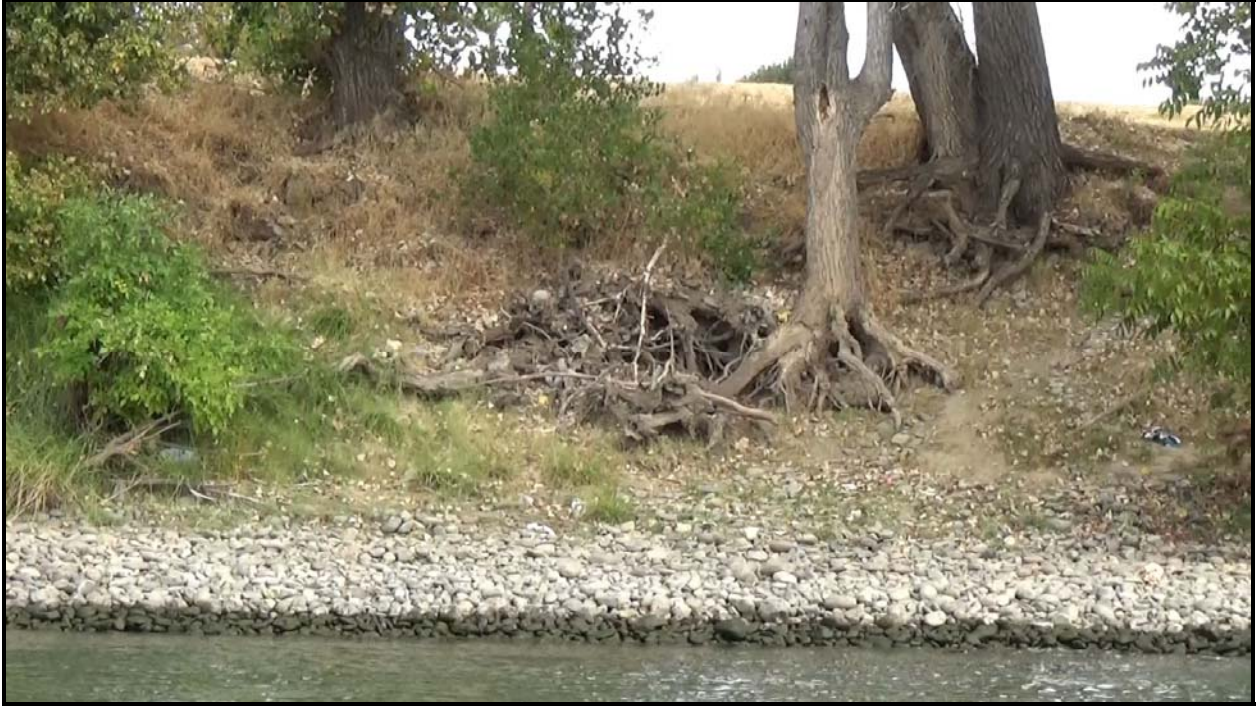
Sacramento River RM 60.3 Left – Recreational use is frequent at this site, contributing to the degradation of the embankment. Most of the trees along the levee slope have exposed roots. In 2013, one of the larger trees caught fire and fell over. The tree is no longer on the bank, but the void created by the uprooted portion of the tree is on the upper bank and the area should still be monitored to identify additional erosion or degradation, especially during and after rainfall. Overall, fill with vegetation on the upper bank is a possible solution to stabilize the bank. This site does not appear to represent an immediate threat to the levee based on the low velocities that characterize the reach; however, a more detailed site analysis could reveal that corrective action is required. The District has historically performed minor maintenance in the area to address erosion at the top of the slope. This site should continue to be monitored and maintained.

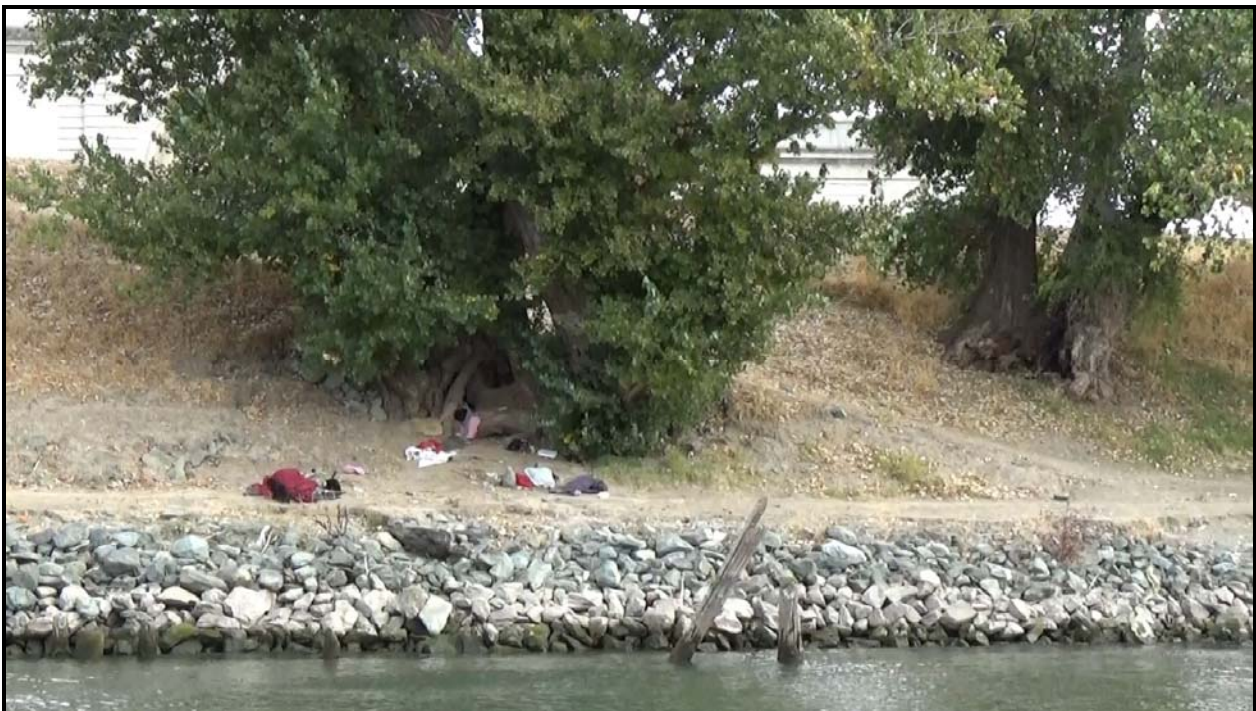
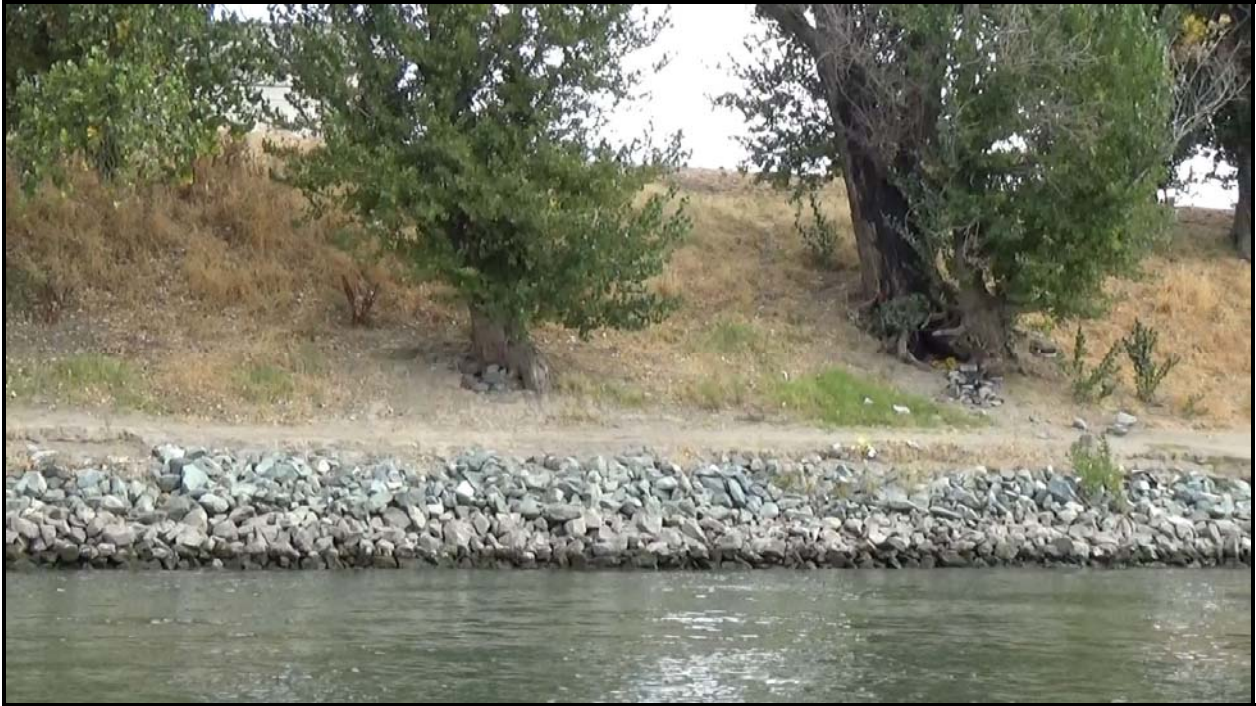
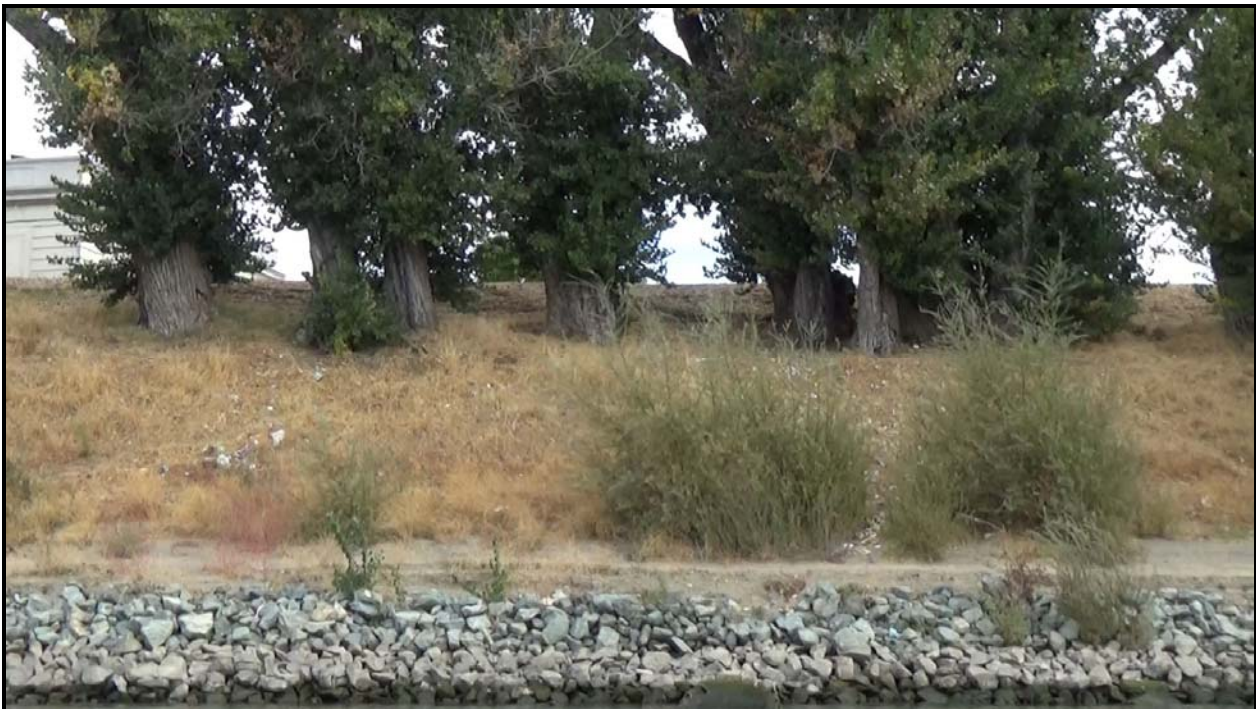
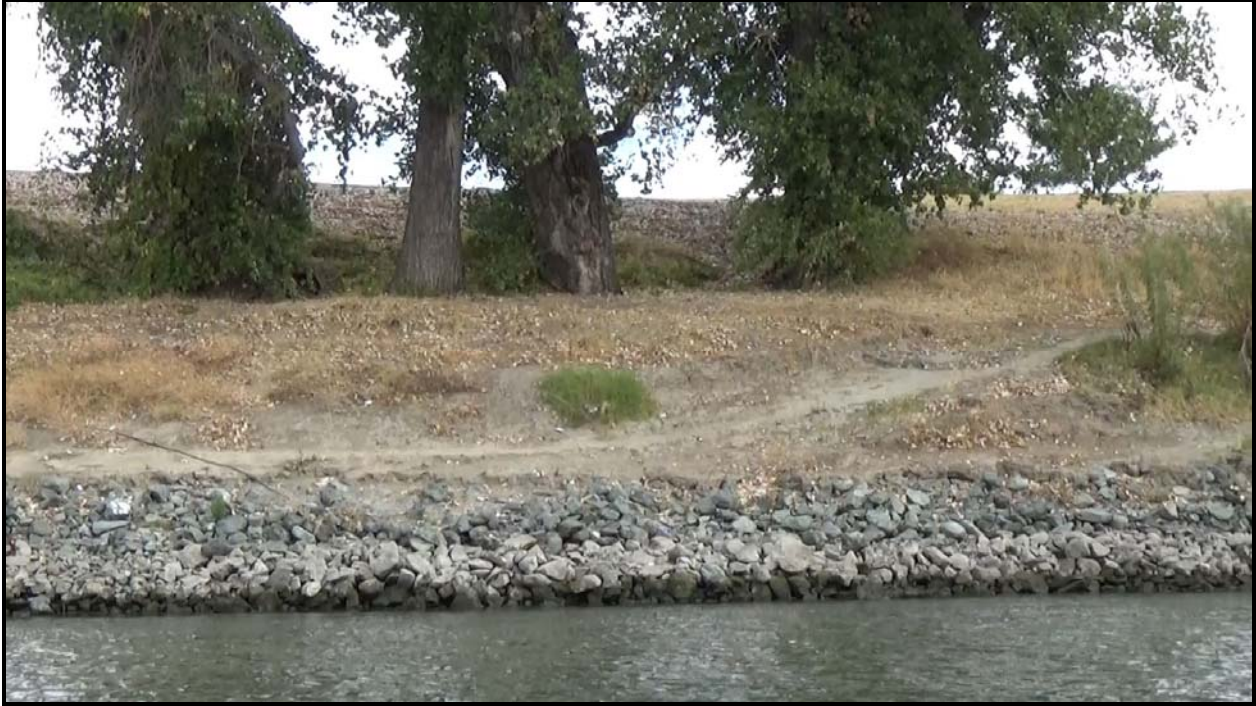
Sacramento River RM 60.1 Left – This site was repaired in October 2011. The site repair

included a riprap bench established at the waterline to protect the bank from wind generated waves and boat wakes. Fill material was placed above the riprap to repair the eroded embankment. The site was hydroseeded in an effort to minimize future erosion. The willow trees that were planted in 2013 along the rebuilt slope remain, but have continued to struggle. The original riprap and embankment repair appears to be holding up well and no further repairs are necessary at this time.

Sac River 60.1L	100 feet	2006	Site is between the old water intake facility and the new intake facility. Site was repaired in October 2011. Repaired levee appears to be in good condition.	>3 fps	>3 fps	Bike trail at top of bank. High recreational use.	In October 2011, a riprap bench was established at the waterline to protect the bank from wind generated waves and boat wakes. Fill material was placed above the riprap to repair the eroded embankment. The site was hydroseeded in an effort to minimize future erosion. Aside from struggling willows that were planted in 2013, repair efforts have been successful and levee appears to be in good condition.
