American River Flood Control District
Fence Encroachment at 2316 Rogue River Drive
Staff Report

RIGHT OF WAY EXHIBIT

SAFCA
AMERICAN RIVER SOUTH LEVEE ENCROACHMENTS

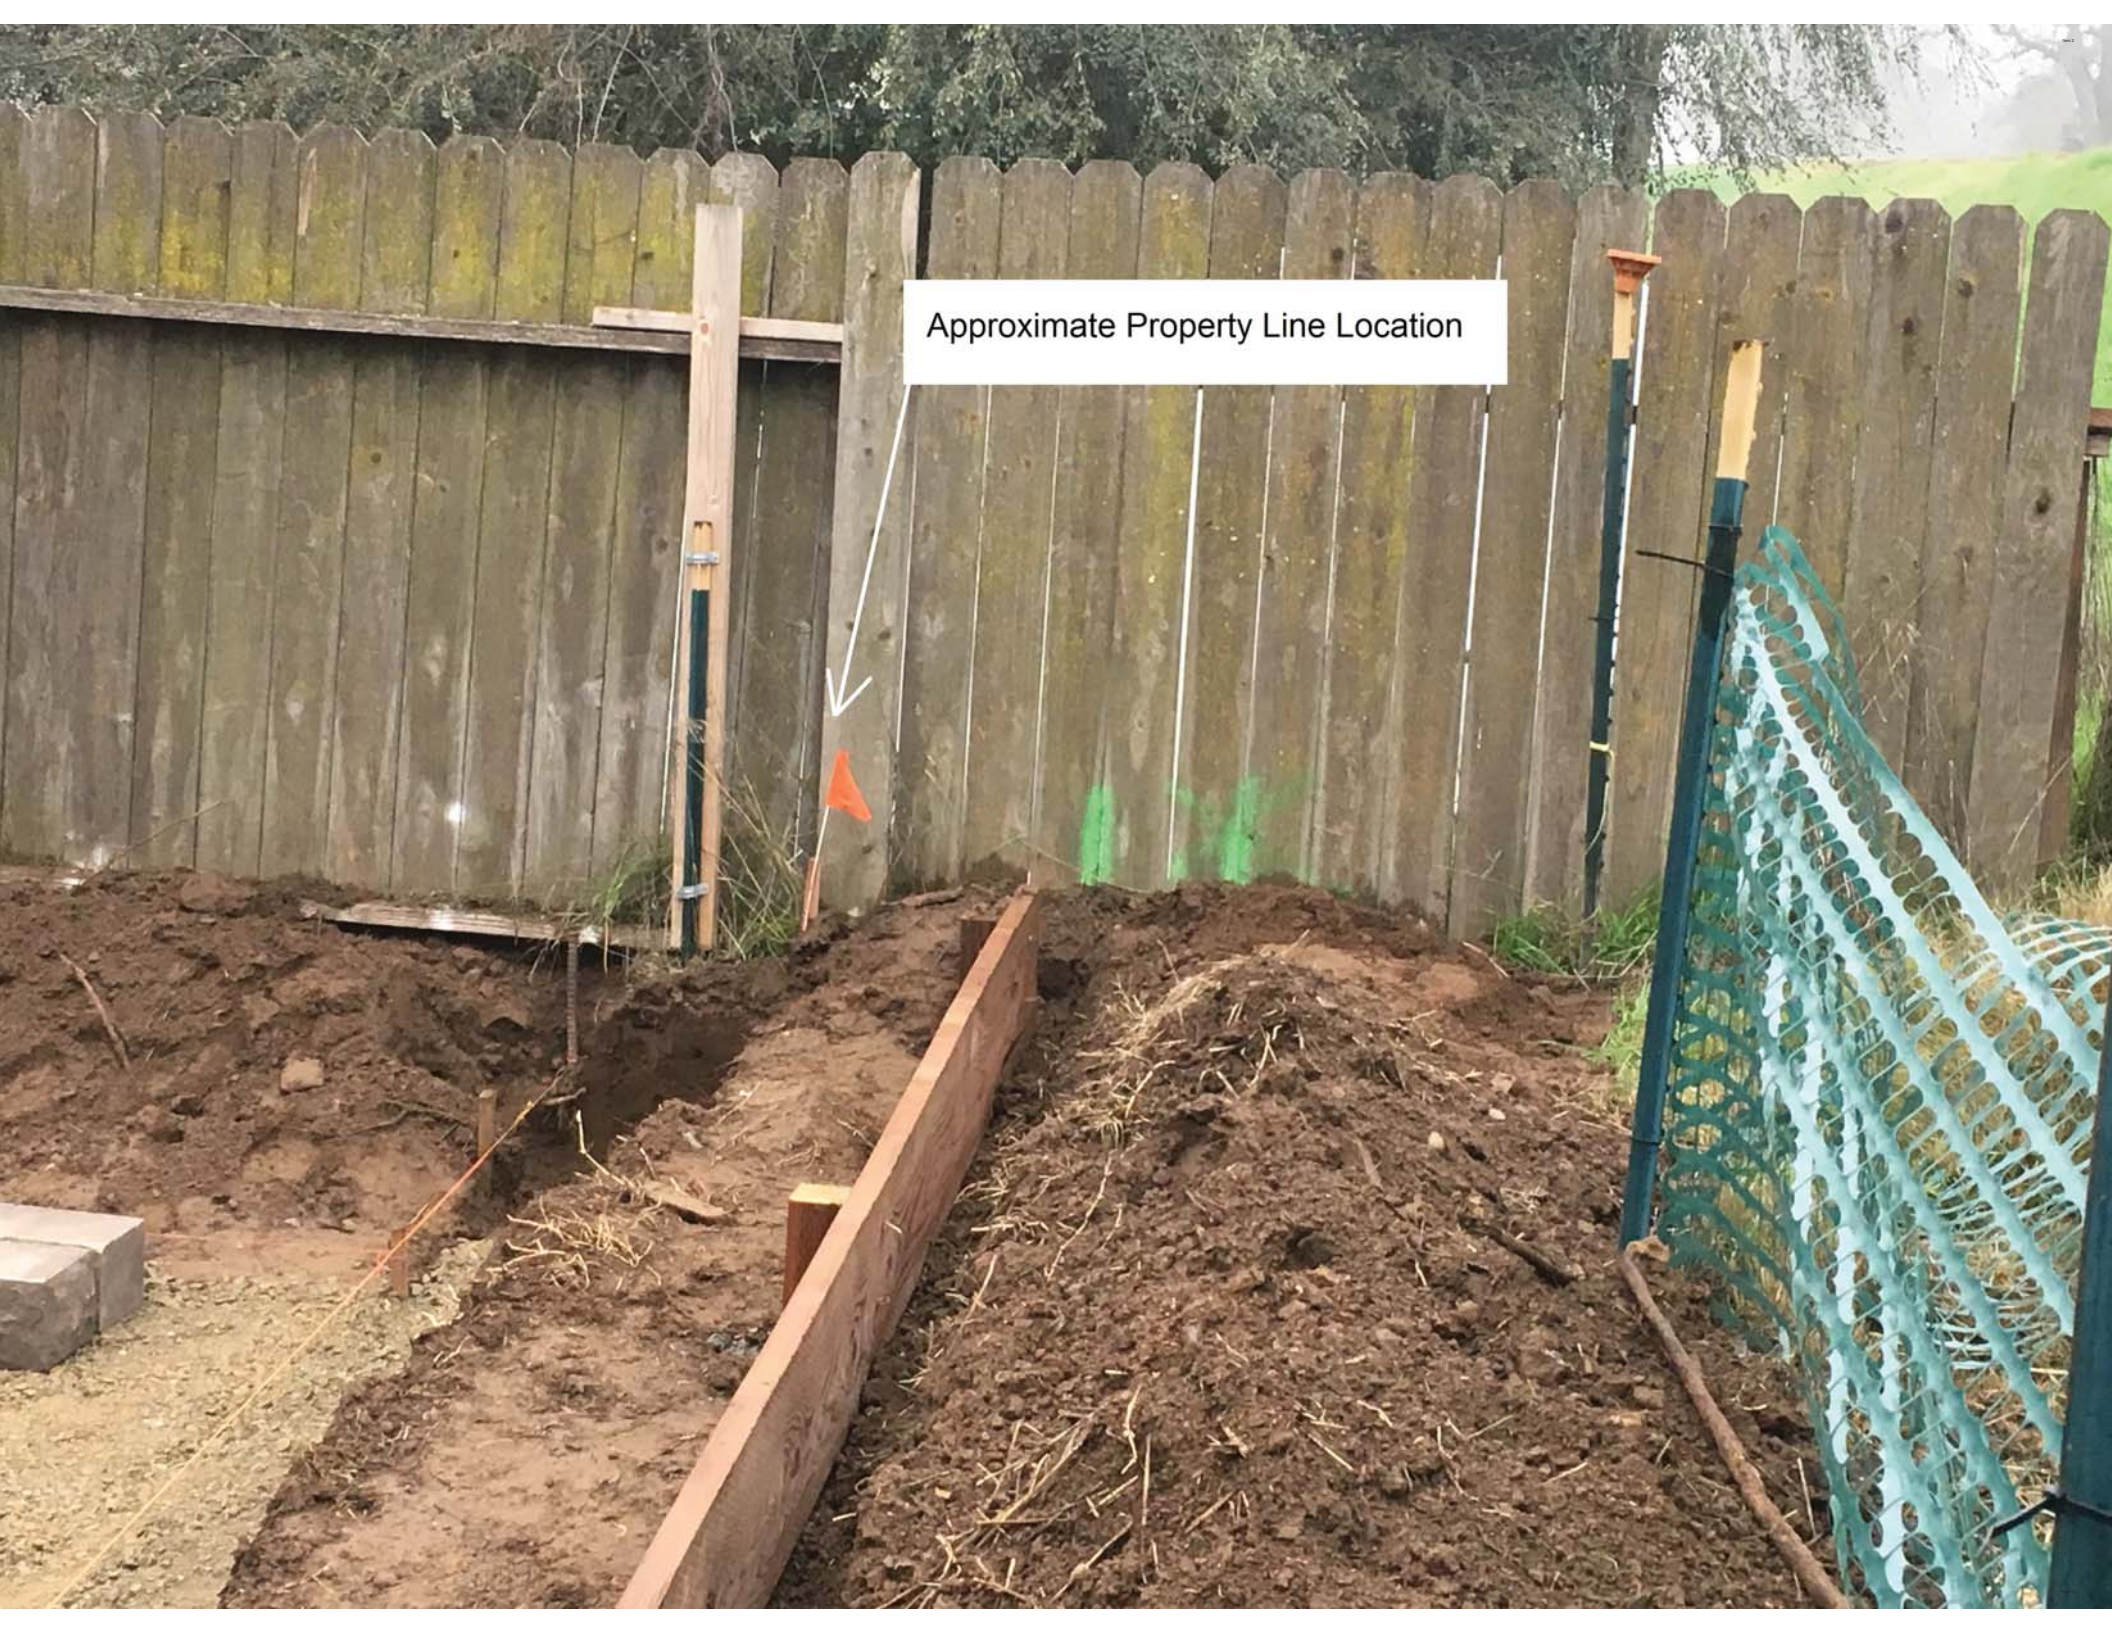
Approximate Property Line Location

In December 2016, the District observed that a large walnut tree had fallen near the levee toe at 2316 Rogue River Drive and damaged two adjacent residential structures. A remaining tree at that location showed signs of declining health and was suspected to be a risk for toppling also. The District had a property boundary/encroachment survey that indicated the fence at 2316 Rogue River was 9-feet encroached onto the flood control easement and that the tree was also likely to be on the District easement. The survey was performed by Psomas for SAFCA to identify encroachments and is not an exact property boundary survey.

The two residential parcels on either side of 2316 Rogue River Drive each have encroached fences. One fence is 6-feet encroached and the other is 9-feet encroached. These two fences will need to be relocated to the property line at some point in the future.

The General Manager recommends that the District offer to remove the constructed portion of the fence at 2316 Rogue River with the intention of preserving as much of the materials as possible. The District should be on-site to verify that the fence is re-installed on the actual property line with a deviation of no more than 6-inches.

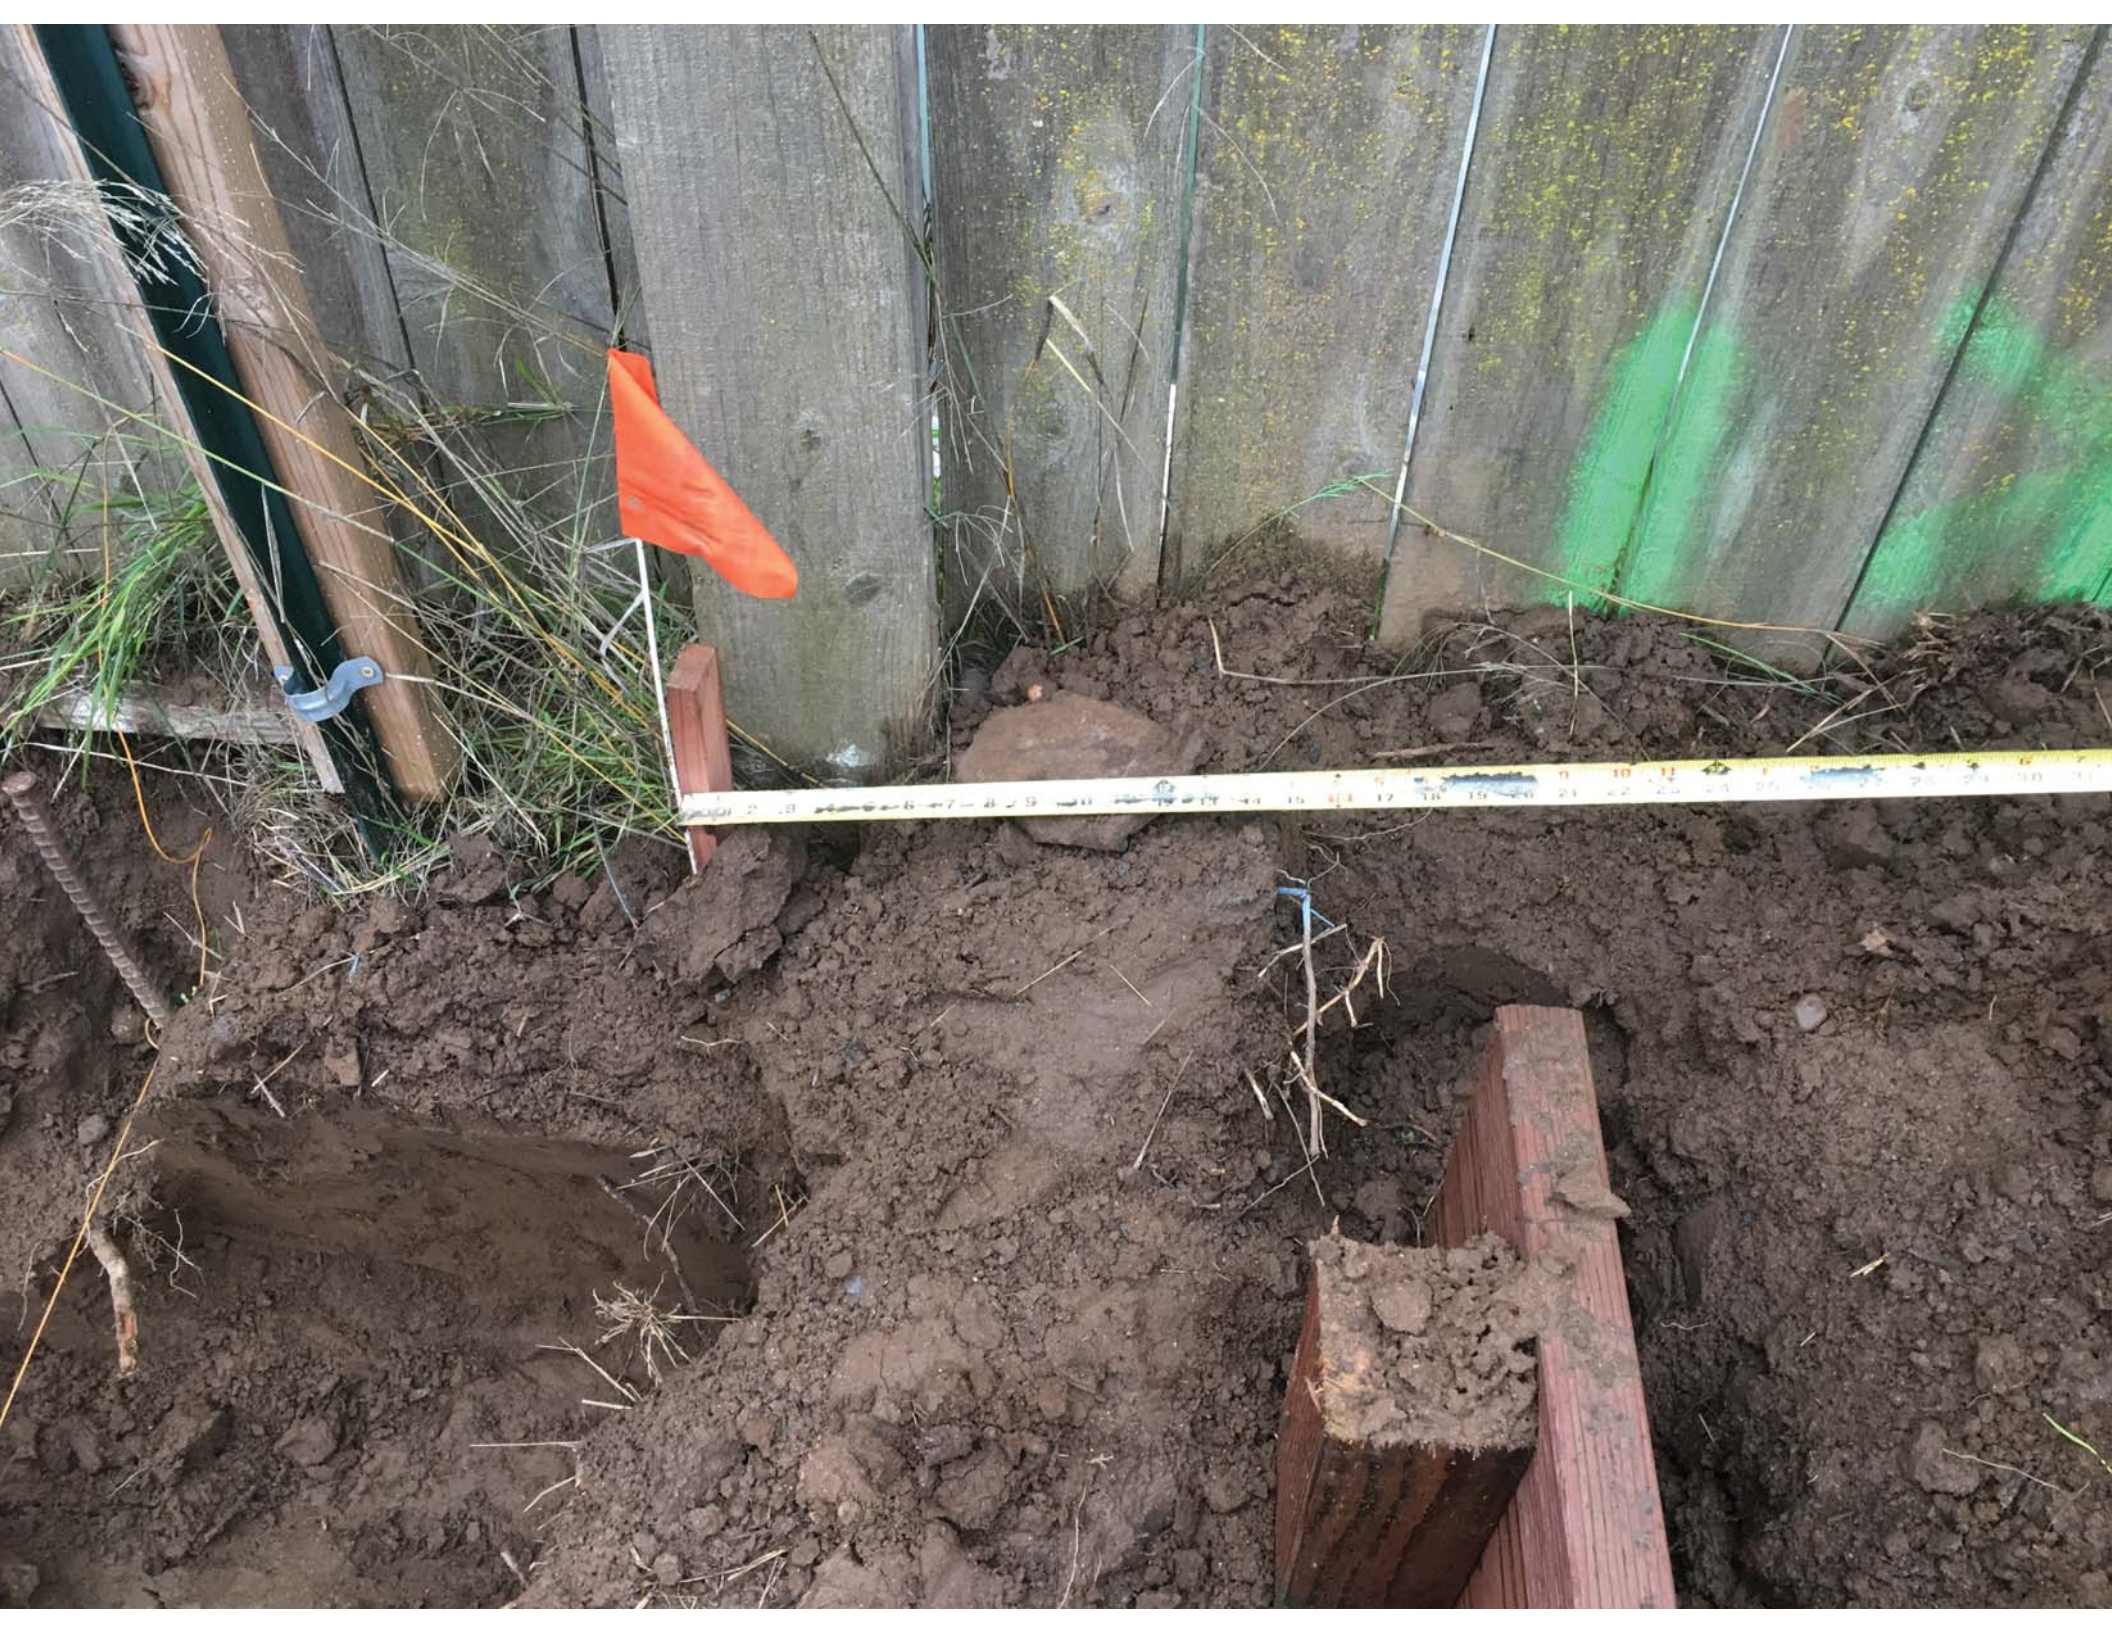
DATE: 08/20/2014 SHEET: **4**

1. The purpose of this survey is to provide information about possible encroachments for selected properties along the American River South Levee. Photos surveyed fences and utility poles to determine their locations relative to the residential property lines. Dimensions shown are the distances that the fence/pole is over (north of) the property line.

2. The residential property lines were established by Psomas utilizing found record monumentation along the centerlines of the streets. The record subdivision lot lines were calculated and placed by best-fit method onto the found record monumentation. Individual lot surveys were not performed.

5. Due to height distortion inherent in the orthophotography, the distance from buildings to property/encroachment lines may appear different than actual conditions.

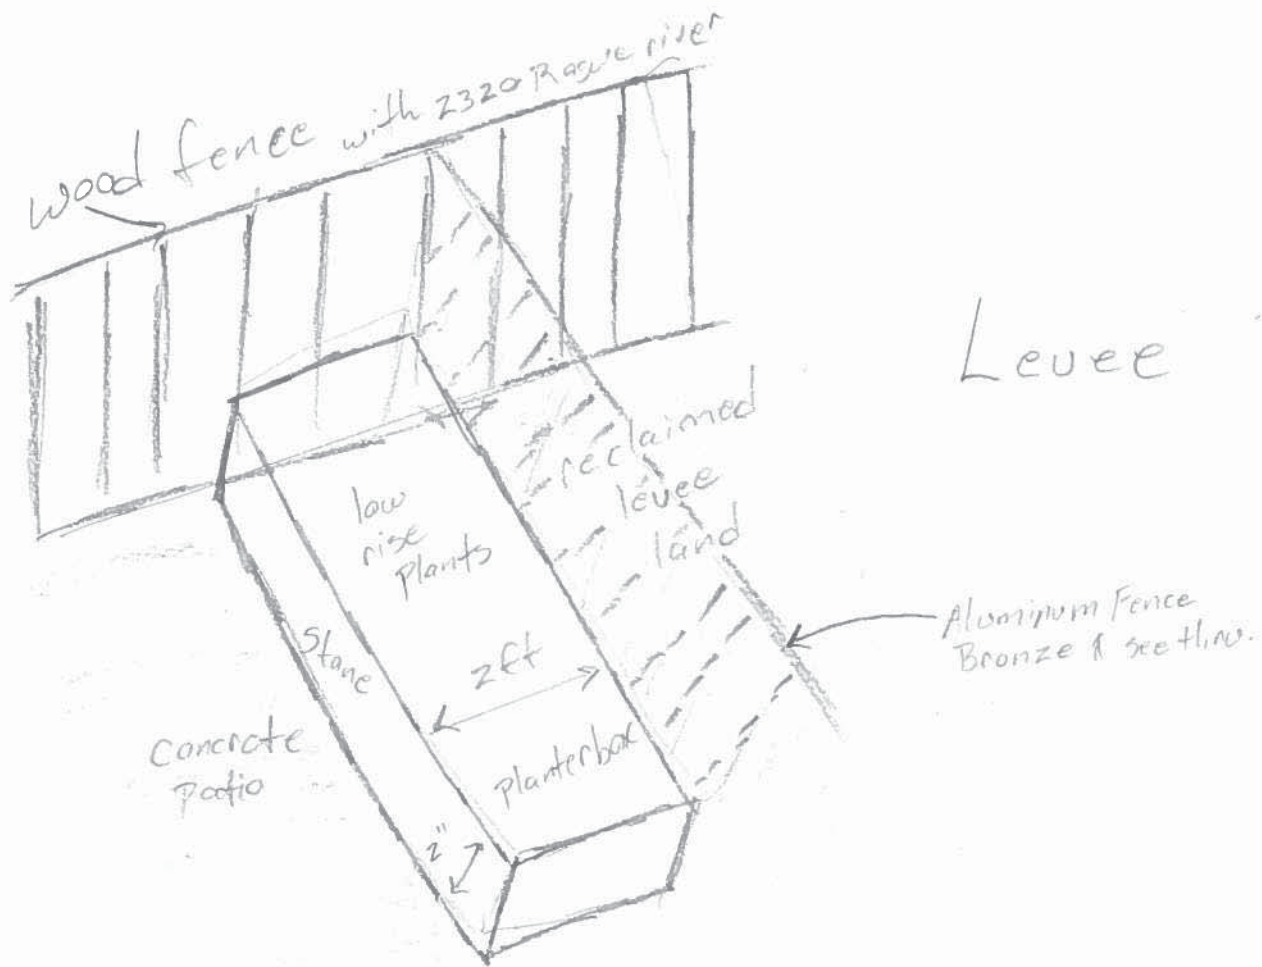
> My crew noticed fence construction occurring at your parcel at 2316 Rogue River Drive. It appears the alignment is not going in on the property line as agreed. The upstream corner is correct but the downstream corner is on the flood easement by about 2-feet.

> We would very much appreciate if your could correct this. We will not be able to cost-share in the construction of the fence if it is not on the property line. Also, my Board would need to consider any other State requirements for pursuing this as an unauthorized encroachment.
