2017 Lower American River Streambank Erosion Monitoring Report

April 2018

Prepared for:
American River Flood Control District
&
Sacramento Area Flood Control Agency

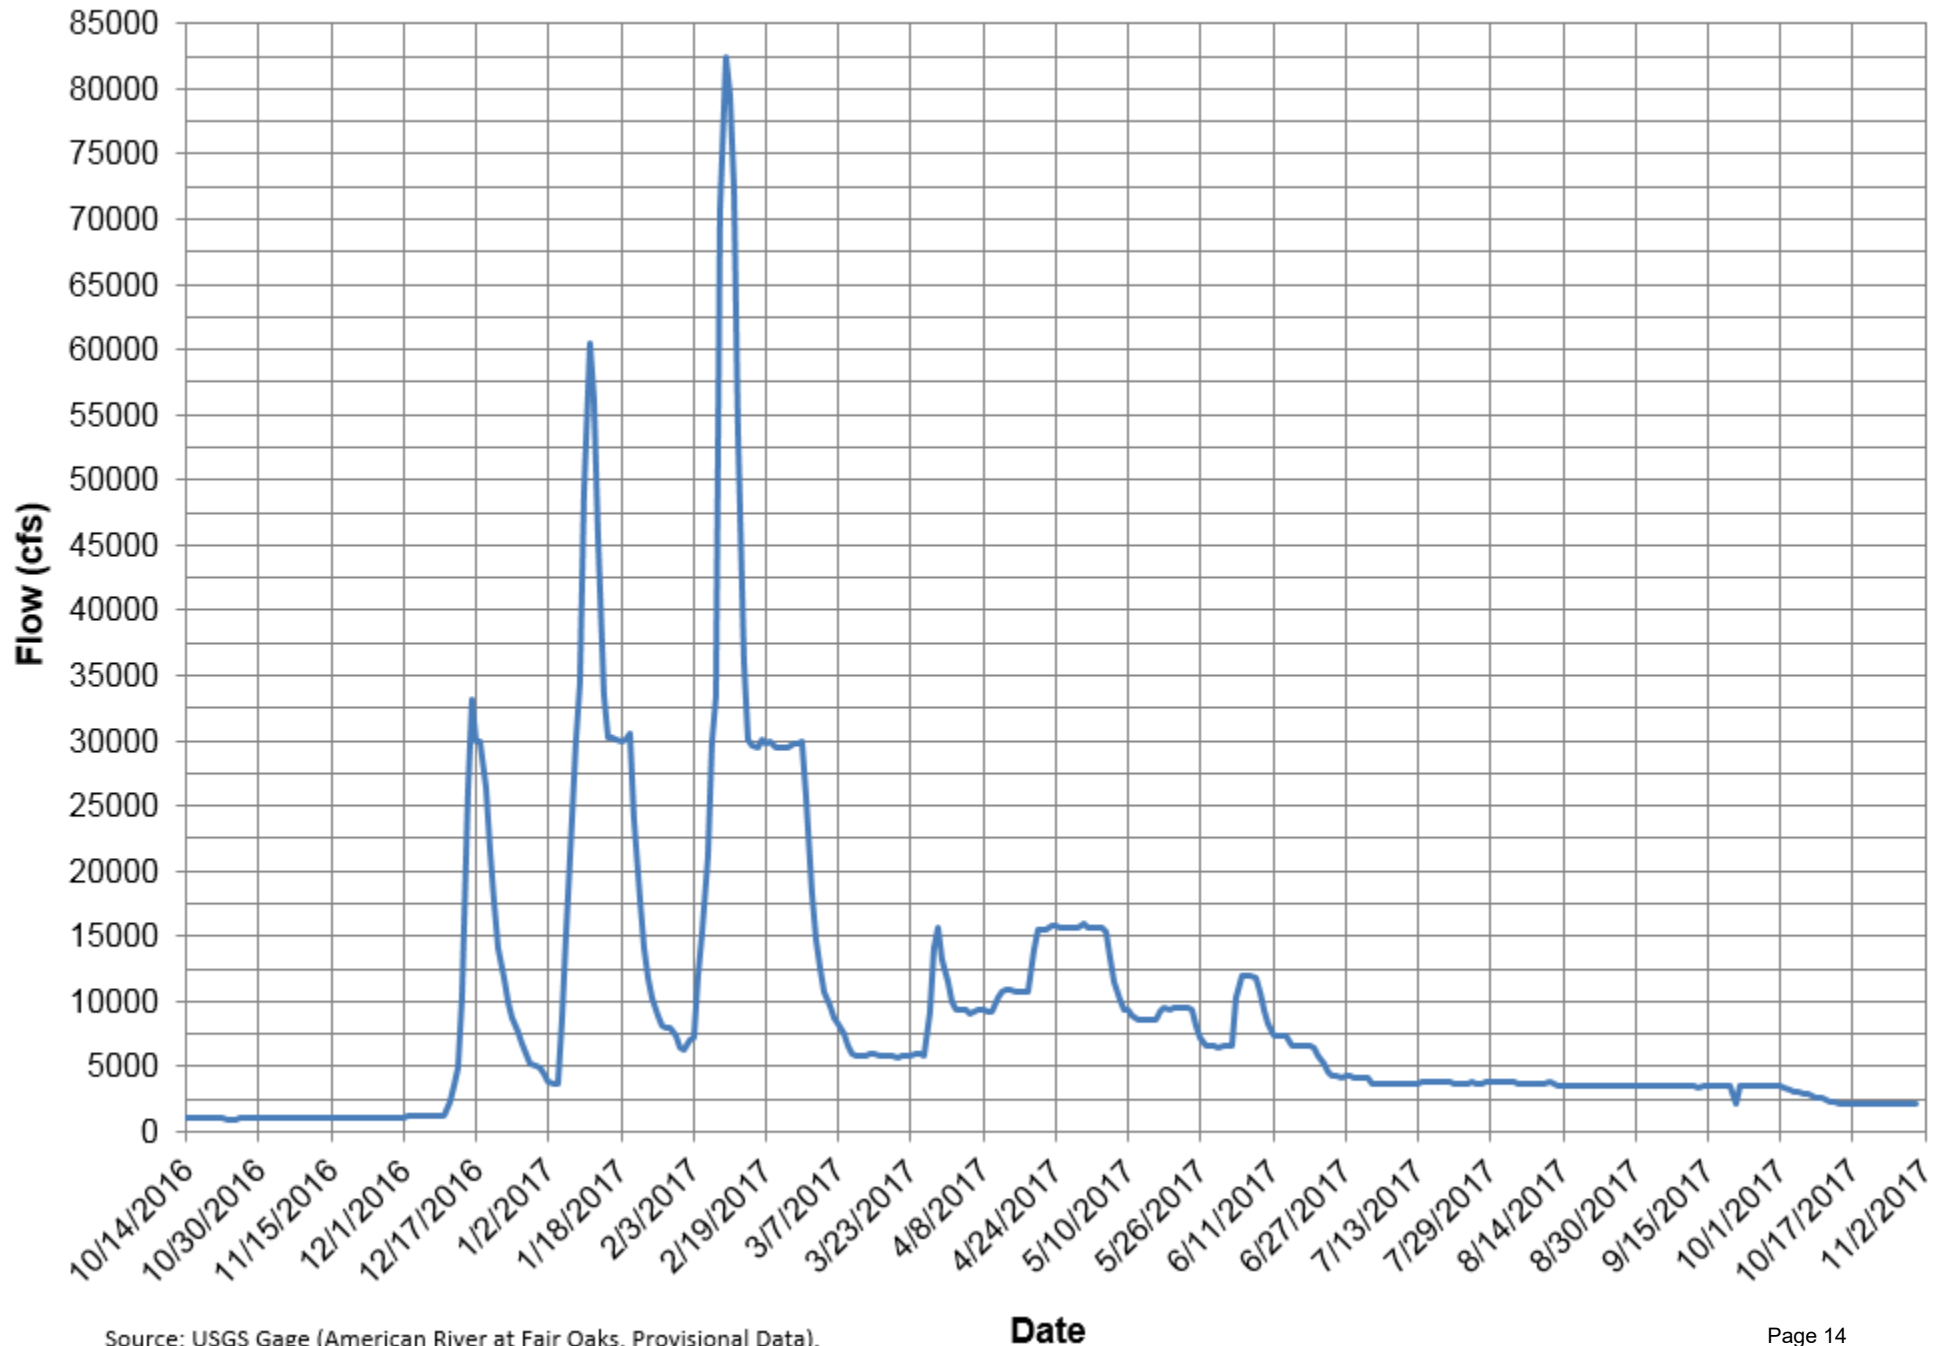
Figure 2 - Mean Daily Flows on the American River

Figure 2 shows the mean daily flows for the American River from October 14, 2016 through October 31, 2017. This year's inspection occurred on October 17, 2017. The maximum peak flow since the previous inspection date (October 13, 2016) was 82,400 cfs, occurring February 10, 2017. The peak flow of 82,400 cfs is significantly greater than the previous inspection year's peak flow of 20,200 cfs, occurring March 13-15, 2016.
